Inspection Report

INSPECTION REPORT

Inspection Location | Mixing Center

Equipment Identification | Mixing Line

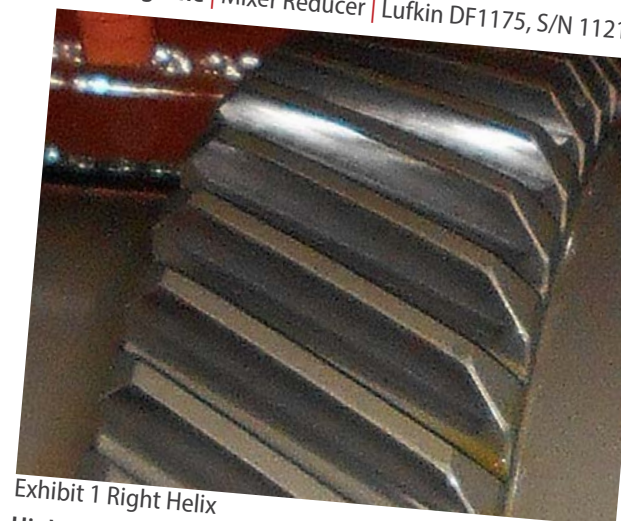
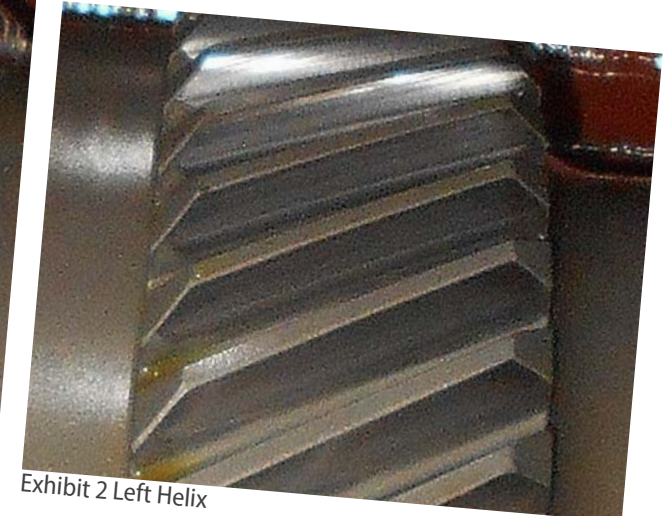
High Speed Pinion | Exhibit 1, Exhibit 2

The contact appears to be 100% in length and area across both helixes with normal wear present. There is polishing present across both helixes.

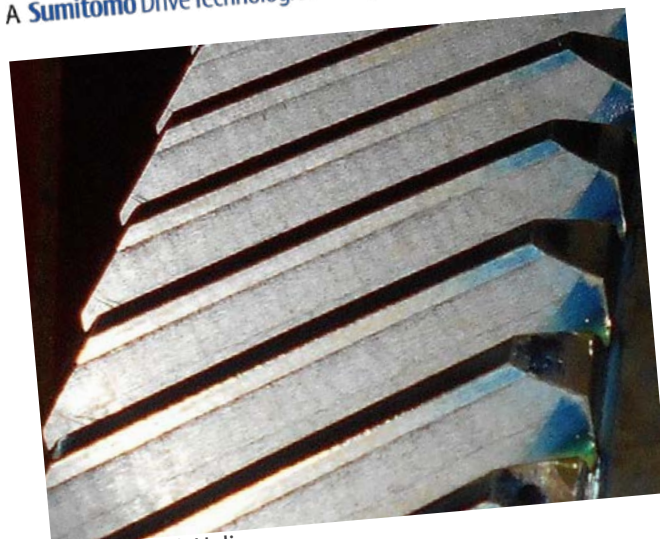
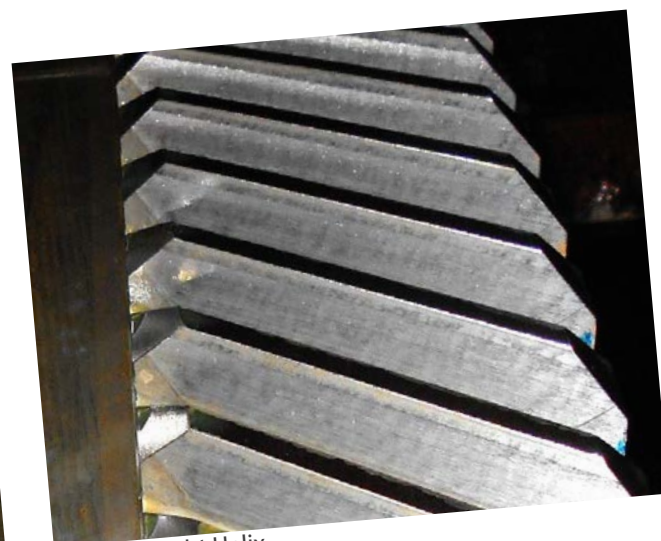
High Speed Gear | Exhibit 3, Exhibit 4

The contact appears to be 100% in length and area across both helixes with light wear present. There appears to be some light frosting with polishing present across the helixes.

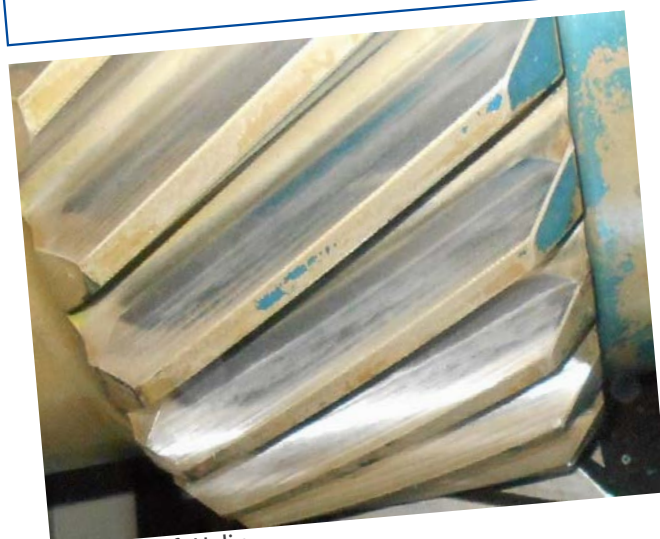
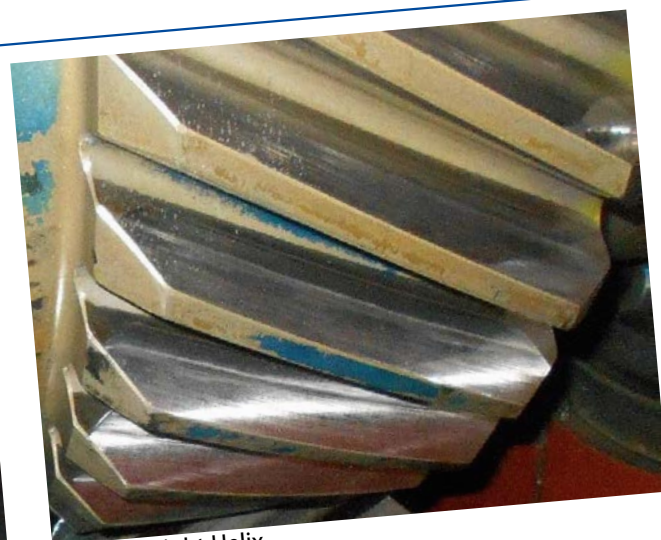
Low Speed Gear | Exhibit 5, Exhibit 6

The contact appears to be 100% in length and area across both helixes with normal wear present. There is polishing present across the helixes.

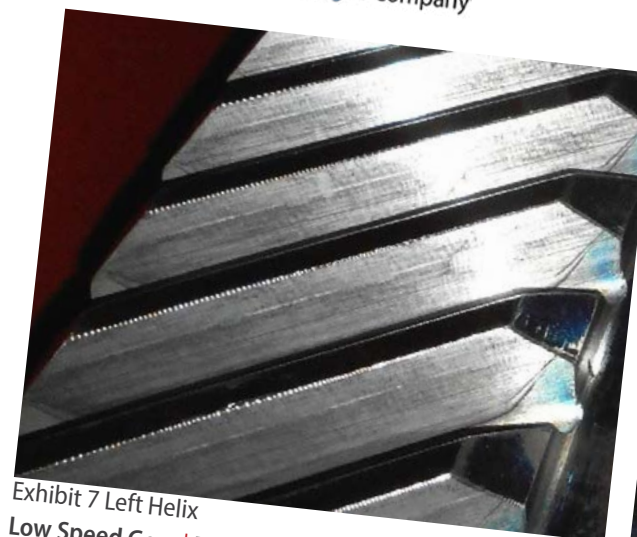
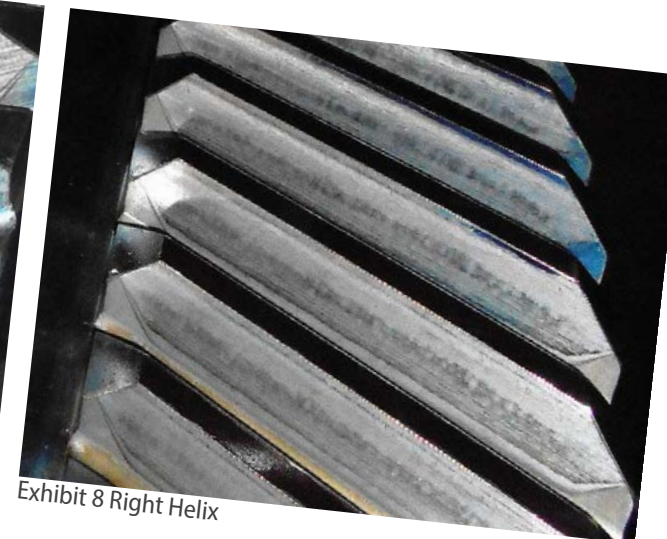
Low Speed Gear | Exhibit 7, Exhibit 8

The contact appears to be 100% in length and area across both helixes with light wear present. There is drosting and abrasive wear present across the helixes with possible signs of run out present. This can be seen in the photos above with the tooth engagements. However, this would need to be confirmed.

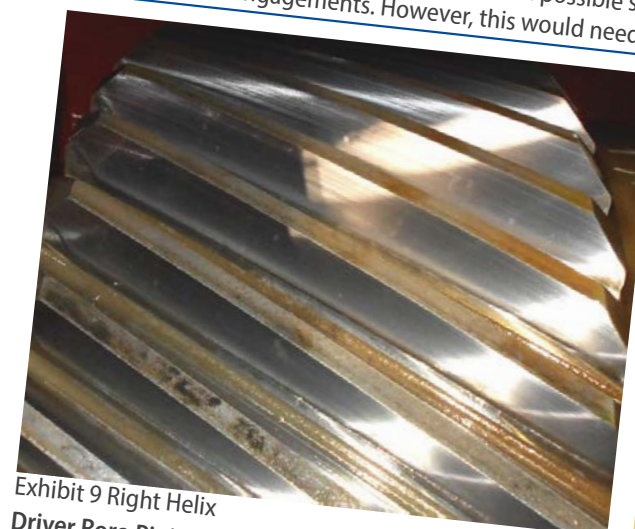
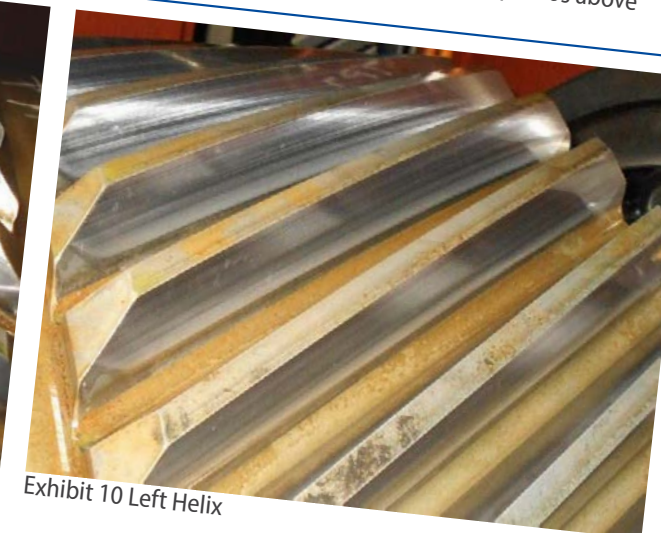
Driver Roro Pinion | Exhibit 9, Exhibit 10

The contact appears to be 100% in length and area across both helixes with normal wear present. There is polishing present across the helixes.

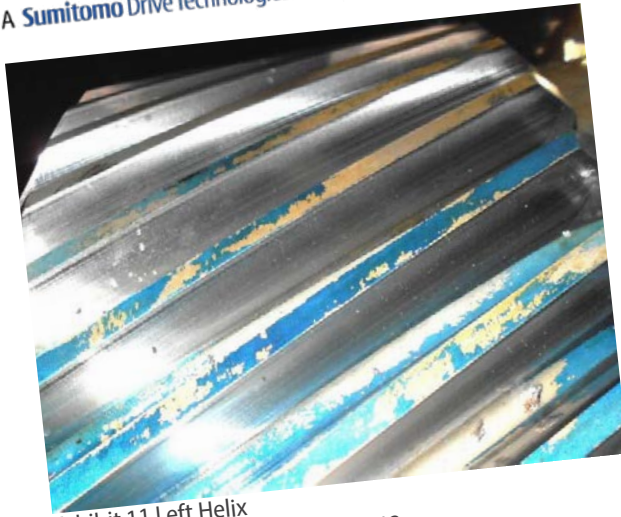
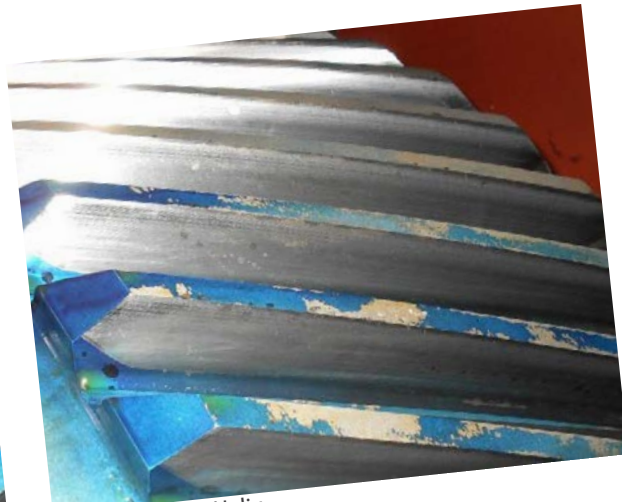
Exhibit 11 Left Helix
Driven Roto | Exhibit 11, Exhibit 12

The contact appears to be 100% in length and area across both helices with normal wear present. There is polishing present across the helices.

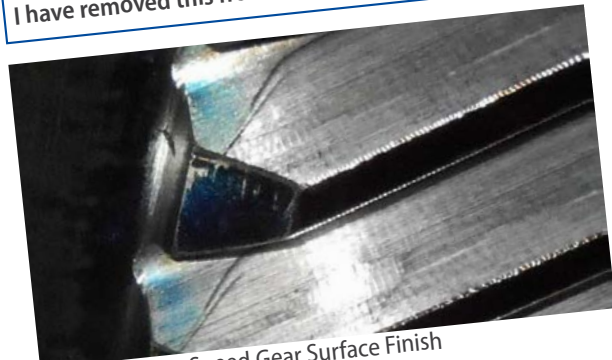
The inspection found no real issues with most of the rotating elements. However, we did find what appears to be run out present on the low speed gear and the surface finish is very rough. This can be seen in exhibit 13 below. The run out needs to be confirmed as it could cause long term issues with wear on the low speed gear. There are a couple of options with how this can be done depending on whether the bearings are in carriers or just sitting in the housing bores. There was no visible change in the rotating elements from 2016 to 2017 inspection. The line of contact as seen on exhibit 13 is still present and it is more pronounced now. There were oil leaks now present on the unit that were not present during the 2016 inspection. I have removed this from monitor as there appears to be no change in the wear that is present.

Exhibit 13 Low Speed Gear Surface Finish

There are 2 different contact lines on the teeth as seen in this exhibit.

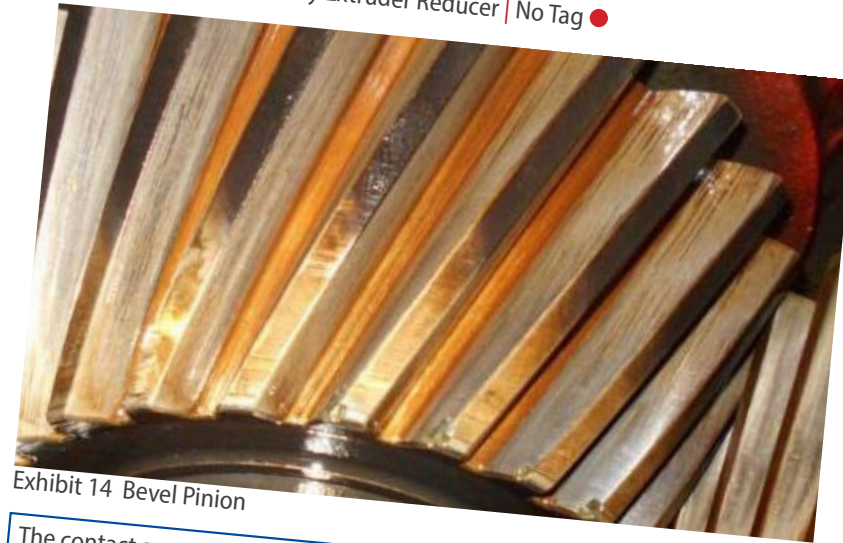
Exhibit 14 Bevel Pinion

The contact appears to be normal and full length of the teeth with some signs of polishing present. There are some chipped teeth that need to be addressed before they continue to break in sections.

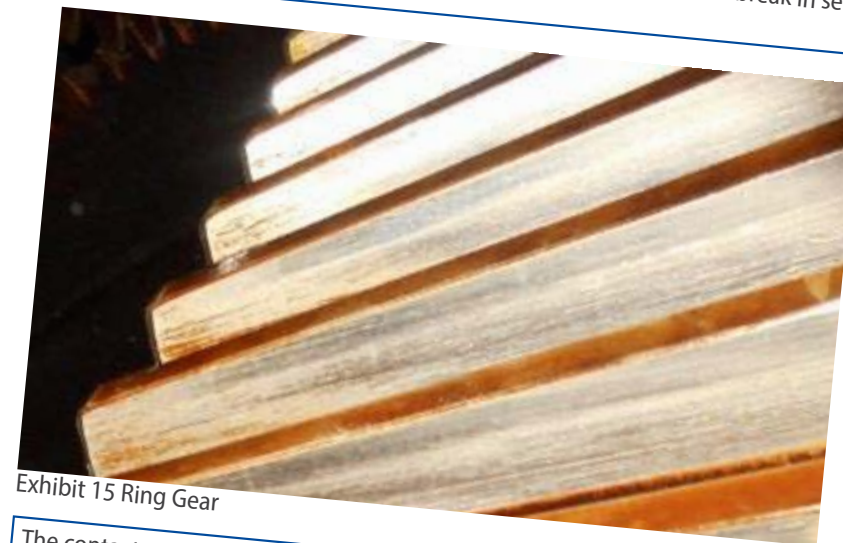
Exhibit 15 Ring Gear

The contact appears to be normal and full length of the teeth with some signs of polishing present.

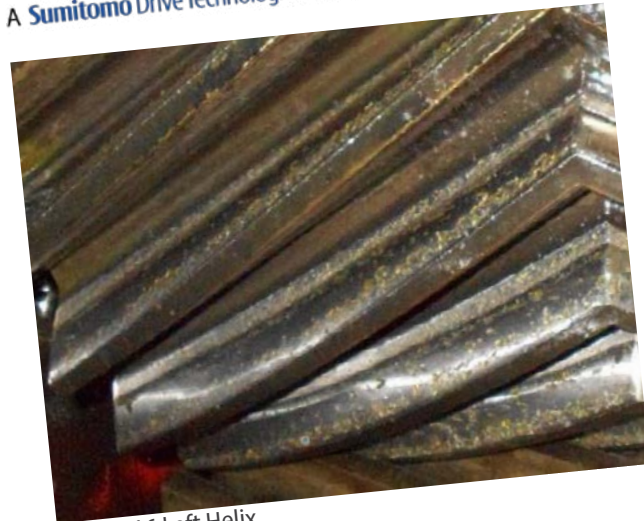
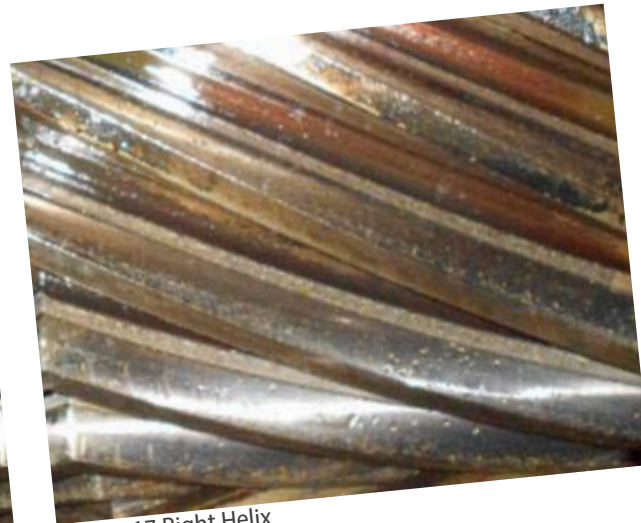
Exhibit 16 Left Helix
Low Speed Pinion | Exhibit 16, Exhibit 17

The contact appears to be 100% in length and area across both helixes with light to moderate wear present. There is undercutting present in the dedendum at the root with frosting and pitting present. There is frosting and abrasive wear now present in the addendum with signs of plastic flow in the beginning stages.

The inspection found no issues with the bevel gear set. The low speed set had destructive type wear present with the undercutting and plastic flow present. The unit will continue to run however, the wear will progress and over time it will need to be address. Presently, just the low speed set needs to be replaced at some point. The life of the present set can be extended by de-burring the edges to stop cracks from forming and this will give you more time to address the issue of replacement of the gear set. There are chipped teeth present on the bevel pinion. These should be de-burred as soon as possible to avoid any further breaks.
The unit was not inspected in the 2017 inspection. Wanted to include this based on the condition.

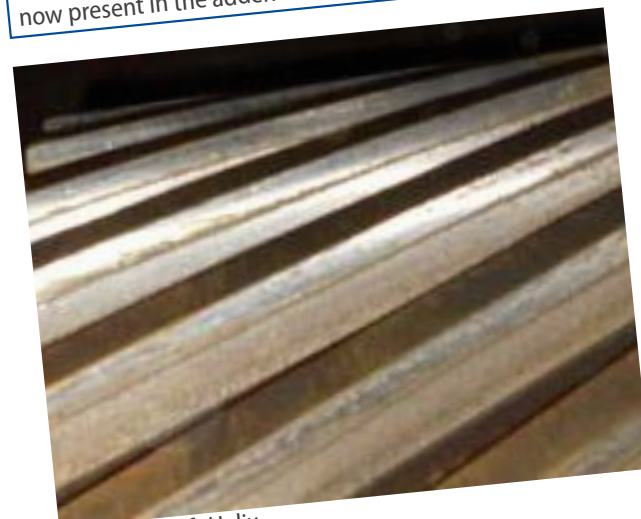
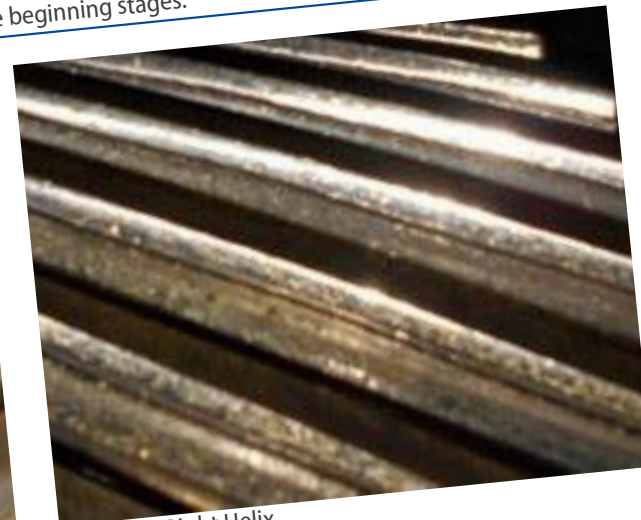
Exhibit 18 Left Helix
Low Speed Gear | Exhibit 18, Exhibit 19

The contact appears to be 100% in length and area across the helixes with light to moderate wear present. There is undercutting present thru the dedendum into the addendum with frosting and pitting present. The remaining area of the addendum has plastic flow present.

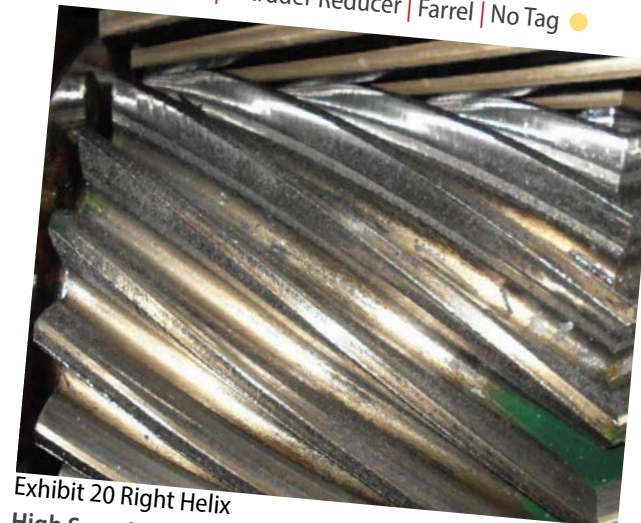
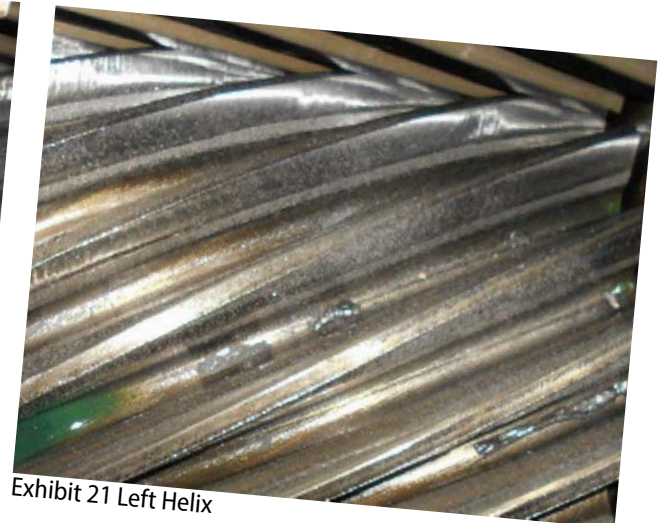
Exhibit 20 Right Helix
High Speed Pinion | Exhibit 20, Exhibit 21

The contact appears to be 100% in length and area cross both helixes with light to moderate wear present. There is undercutting present in the dedendum at the root and signed of plastic flow in the beginning stages in all other areas.

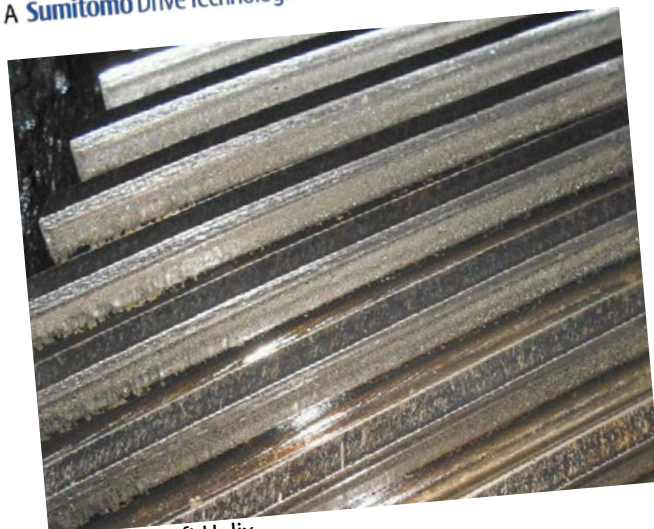
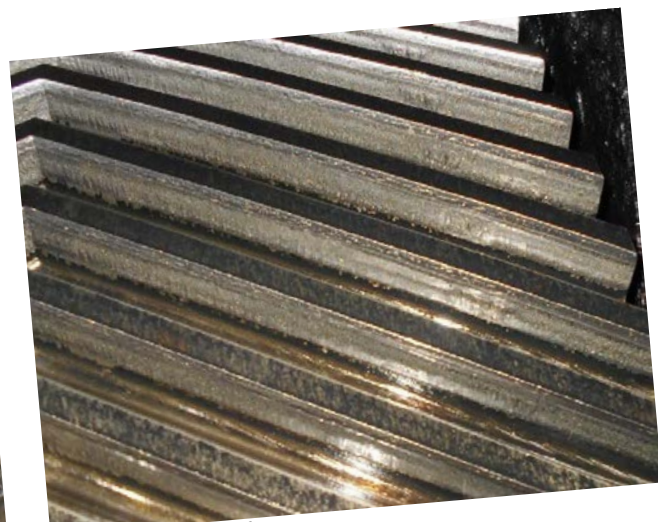
Low Speed Gear | Exhibit 22, Exhibit 23

The contact appears to be 100% in length and area across both helices with frosting and pitting present. There is undercutting present in the dedendum thru most of the addendum with frosting and pitting present. The tip area of the addendum as plastic flow present.

The inspection found destructive wear patterns present on a very old gear set. The wear that is present is fairly normal for a set of gears that has the lubrication applied in the manner of this gear set and for the fact that it is very dirty. The wear will continue to progress and we can monitor the wear and we can, at times, de-bur the edges of the gear and pinion to help extend the life of the elements. At some point, plans will need to include the replacement of the gearing which would not be difficult. At this time, the low speed gear can possibly be re-cut with a new pinion made that would save cost over a new set. Continue to monitor during the yearly inspection.
