IMECE2009-10498

THE RIGOROUS APPLICATION OF FMEA TO A WASTEWATER TREATMENT PLANT AERATOR DRIVE: UNDERSTANDING REQUIREMENTS, CONDITIONS, LIMITATIONS AND SUCCESS FACTORS

Tomoki Tanaka

Daniel J. Rosseljong

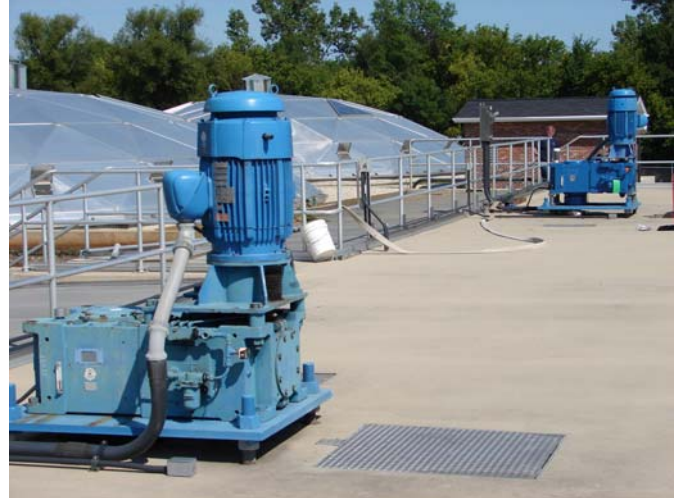
The only differences between the 2 installations are application related: the direction of rotation. Aerator 1 (Left-Figure 3) is clockwise and Aerator 2 (Right-Figure 3) is counterclockwise, when looking down through the gearbox. The gearbox is of a standard design, modified for vertical aerator operation. Modifications include: immersion oil heater, LSS drywell construction, shaft driven pump (to lubricate the upper bearings) and flow switch (for low flow indication of bearing lubrication).

Figure 3. Aerator 1 (Original - Left), Aerator 2 (Replacement - Right)

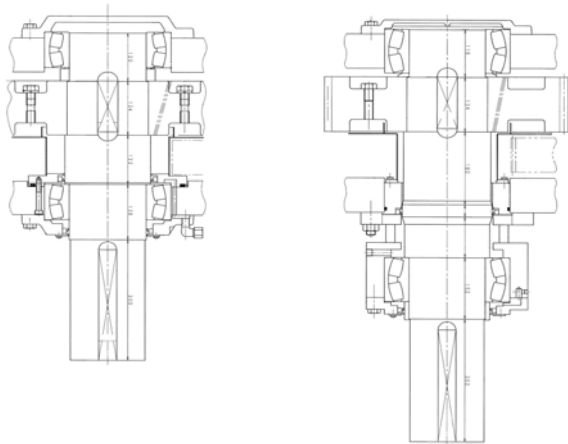
Figure 4. Standard (Left) and Drop Bearing Designs

The OEM and end-user were advised to reduce the internal grease chamber pressure by installing an expansion chamber. It was recommended the user also consider a drop-bearing design to accommodate excessive shaft loads. This design replaces the standard low speed shaft assembly with a longer shaft having a significantly longer bearing span, (Figure 4). It was assumed that the longer bearing span would reduce the shaft deflection and provide excessive service factor to the bearing life, accommodating any aerator loads above the calculated thrust and radial loads.

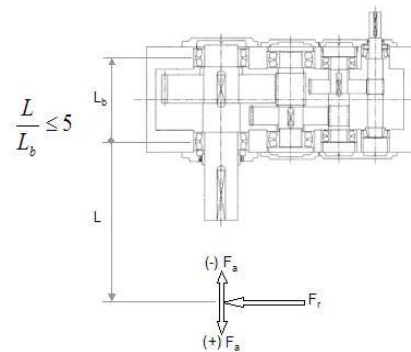
Figure 5. Bearing Span to Aerator Length

A minimum bearing span specification has been instituted for aerator applications to provide a significantly larger margin of safety to accommodate unforeseen and unpredicted application variables. From this application and previous situations, a maximum 5:1 ratio of reducer bearing span to impeller length will be allowed with the standard bearing configuration. A ratio larger than 5:1 indicates that a drop bearing design is required.

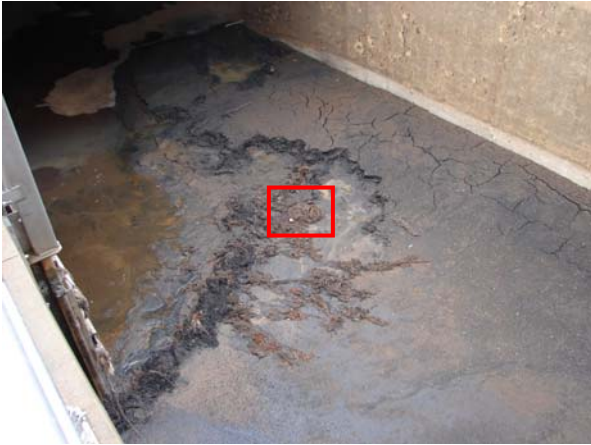
In October 2008, Aerator 1 was replaced with the new heavy-duty drop bearing design. A visual inspection of the tank showed a build up of sediment. Refer to Annex D Figure 6-7 for Photos. The sediment was found to be different than in Aerator 2 tank. This sediment appeared to be mixed with a fibrous textured debris in approximately 20% of the sediment. Again, the impeller was checked for runout and balance. The impeller inspection revealed an imbalance and fractured blade tips. Annex D, Figure 8. A counter weight was added to one of the blades to bring the impeller into balance. Annex D, Figure 9. During the same trip, the gearbox supplier inspected Aerator 2 unit, which had been operating continuously for 2.5 months. The unit temperatures and operation were all found to be within normal parameters. No seal leakage was observed. Aerator 1 unit was returned to the assembly plant for failure analysis.

Figure 6. Aerator 1 Basin Sediment

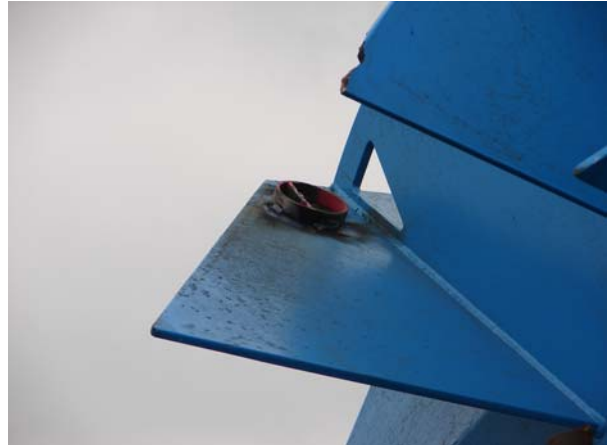
Figure 9. Added Weight to Re-Balace Aerator 1

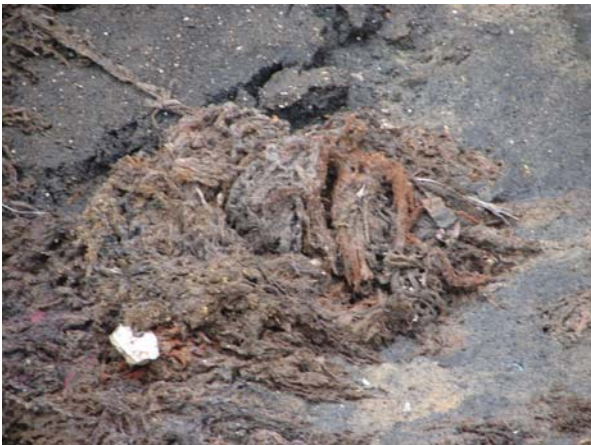
Figure 7. Detail of Fibrous Debris in Aerator 1 Basin

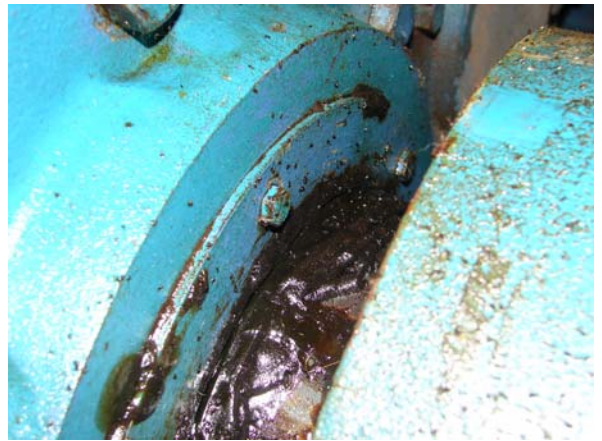
The remaining oil was drained from the gearbox, then nameplate information, low speed seal area and input shaft seal area were inspected. There was heavy grease leakage from the low speed shaft seal. The grease was discolored to black from the light green that was the original color. There was some rust on both low speed and input speed shaft but no significant damage was found. The shaft run-out and also endplay were within the specification. The shaft run-out on low speed shaft was actually 0.100mm and the shaft run-out on input shaft was 0.010mm.

Figure 10. Low Speed Seal Area at Factory Inspection

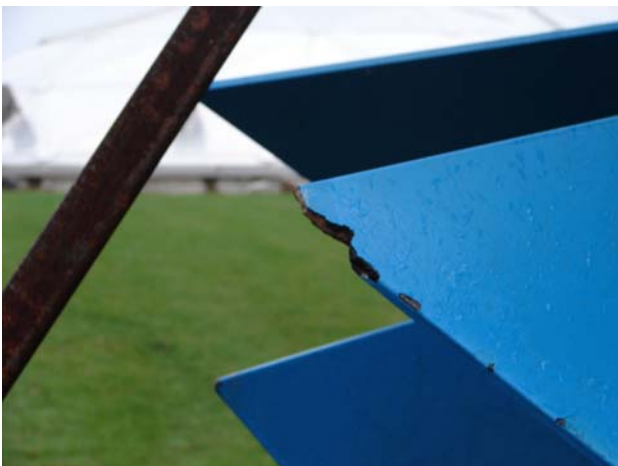
Figure 8. Example of Broken Impeller tip for Aerator 1

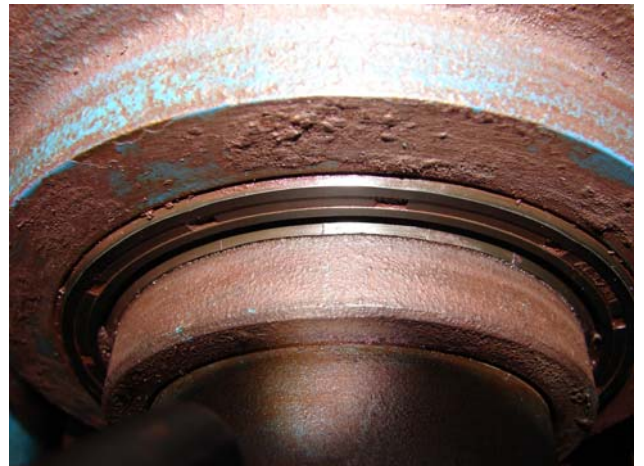
Figure 11. Input Shaft Seal Area at Initial Inspection

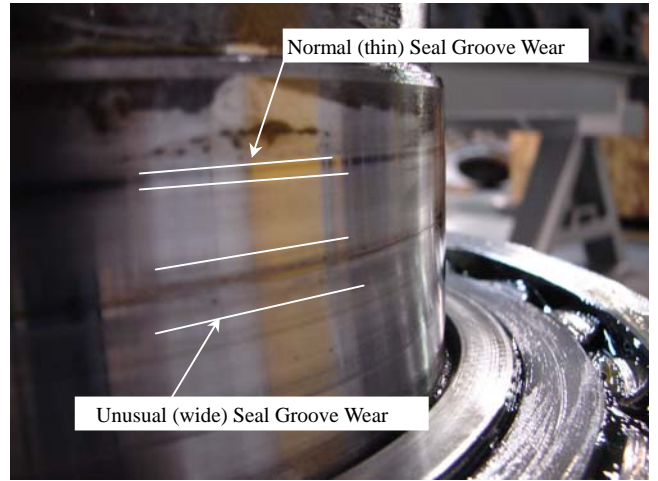
surface, LSS bearing, LSS oil seal and drywell baffle. The LSS had up to 5mm wear marks from the inner seal. The seal grooves, caused by seal wear on the LSS, were found to be acceptable. There was no other significant wear on the LSS at the bearing mounting. The QC Department independently inspected the shaft. All dimensions including runout were found to be within tolerance. The LSS oil seal where the grease came out did not have any significant damage such as softening or brittleness on the OD and lip. The OD of the seal had a dry ‘ring’, which is assumed to mean that no grease penetrated the seal OD. The QC Department also inspected the welding of the drywell baffle. No irregularities were reported.

Figure 14. Low Speed Shaft Seal Contact Area

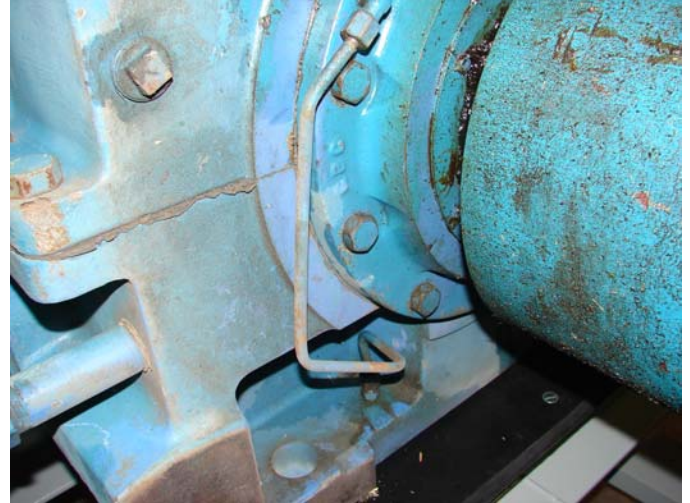
The piping for grease inlet and outlet was removed from the gearbox for the inspection. Upon removal, it was determined that the supply line was holding pressure (after 5 months of inside storage). A pressure test was conducted of grease supply and relief lines to determine if the lube lines had any blockages. Slow & steady pressure was applied up to 100 psi, failing to expel any grease. The piping surface was heated to 162 deg F by a gas burner and the grease exited with some force. The resulting grease composition was solid and pliable. Approximately 8-10 oz of the oil had totally separated from the soap, which had acted as a thick plug in the grease line. A further inspection of the grease lines for aerator 2 gearbox did not exhibit the same conditions. The grease was significantly less viscous.

Figure 18. Low Speed Grease Supply Line

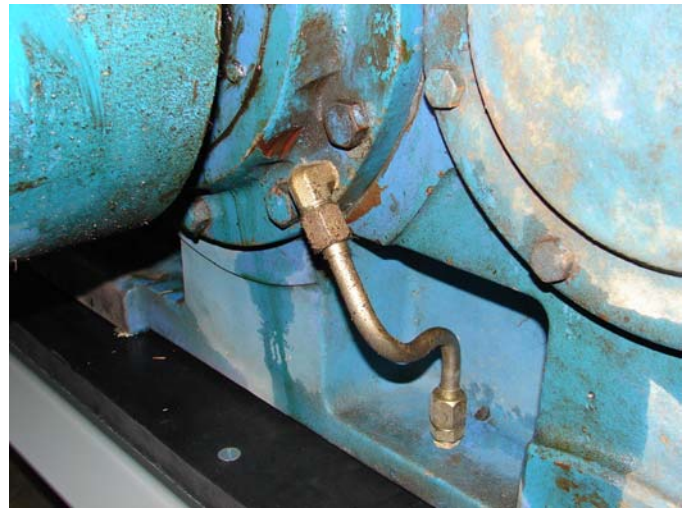
Figure 19. Low Speed Grease Relief Line
