# WHAT ARE YOUR BEARINGS & GEARS TELLING YOU?

BY SCOTT FRANKS, PE

## A LOOK AT TYPICAL BEARING FAILURES, DAMAGE, AND CAUSES IN GEARBOXES

A LOOK AT TYPICAL GEARING FAILURES, DAMAGE, AND CAUSES IN GEARBOXES

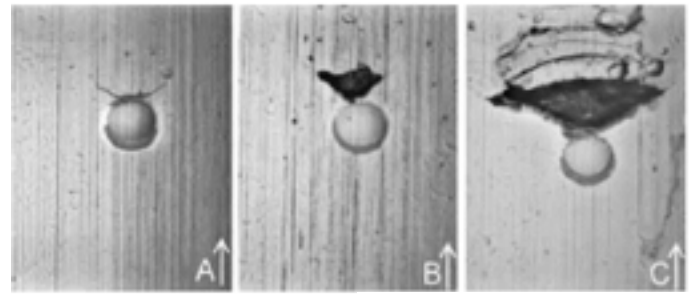
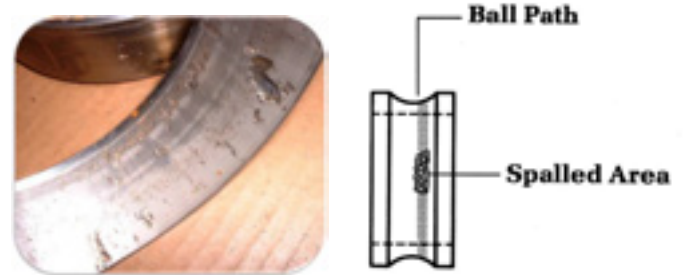
### NORMAL FATIGUE FAILURES

This is characterized by fracture of the running surface and subsequent removal of small, discrete particles of material.

Moderately spalled areas indicate the bearing has reached the limits of its useful life. This can occur on balls, rollers, inner rings, or outer rings.

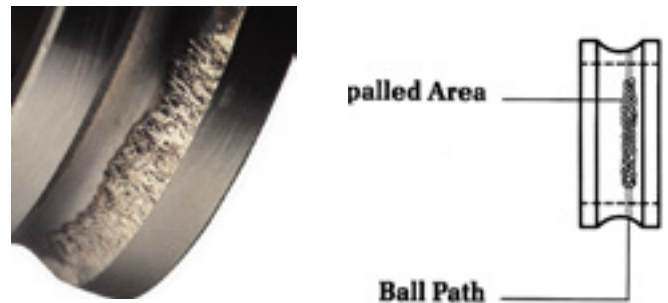
### EXCESSIVE LOAD FAILURES

Symptoms are the same as normal fatigue, although showing heavier ball wear paths, greater evidence of overheating and a more widespread deeper spalling (fatigue area).

When the spall damage appears deeper and over a larger area you should suspect excessive load being the culprit, especially if it happens quickly. The damage may include signs of overheating.

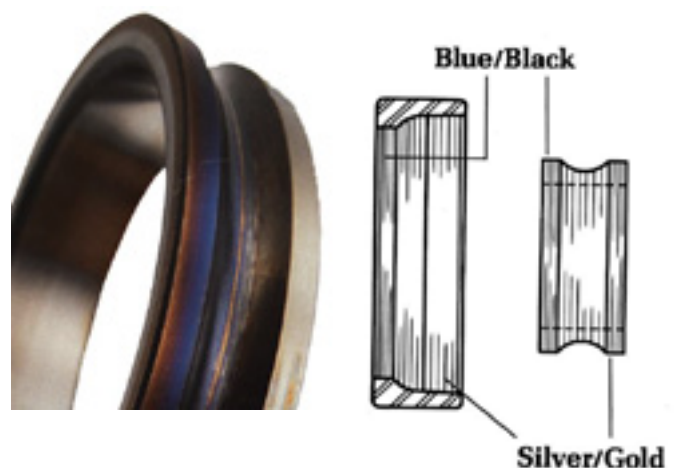
### OVERHEATING FAILURES

- discoloration of the rings, balls/rollers and cages from gold to blue.
- Temperatures in excess of 400°F anneal the rings and balls, making them soft.
- Extreme cases show deformation of balls/rollers and rings.
- Look for blue/black and silver/gold discoloration.
- Balls will usually be blue/black.

You'll see discoloration associated with tempering is usually the first indicator. If the heat is severe enough you will see signs of molten deformation. The lubrication supply needs to be investigated to make sure it's adequate and cool. Bearing clearances need to be validated and speeds verified as not being excessive.

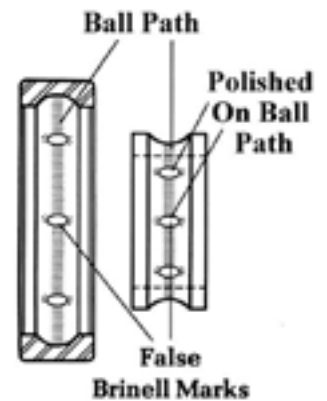
## FALSE BRINELLING FAILURES

Characterized by elliptical wear marks in the axial direction at each ball/roller position. Sometimes surrounded by debris.

Occurs when there is small relative motion between the balls/rollers and raceways during non-rotation times.

When the bearing isn't turning, an oil film cannot be formed to prevent raceway wear. Created by small relative motion between rollers and races when it's not rotating. Usually, a storage or transportation issue due to lack of lubrication. Bearings need something to dampen the contact between the rollers and race.

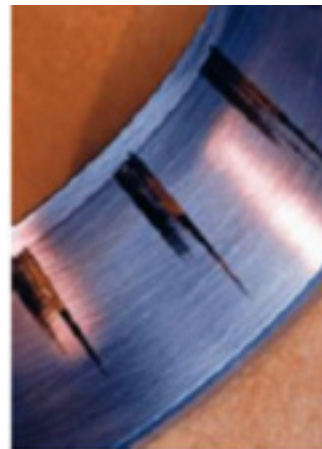
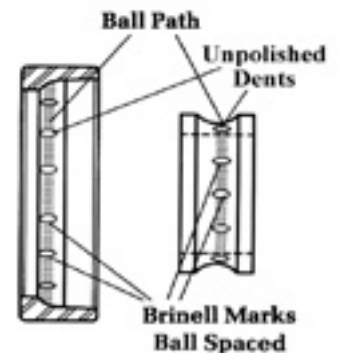
## TRUE BRINELLING FAILURES

Brinell marks show as indentations in the raceways which can increase bearing noise or even cause premature bearing failure. Occurs when loads exceed the elastic limit of the ring material. Any static overload or severe impact can cause brinelling.

- Using a hammer to install a bearing
- Dropping a bearing
- Pressing a bearing onto a shaft by applying force through the rolling elements

Need to review how the bearings are being installed. Especially noting if significant force is being used.

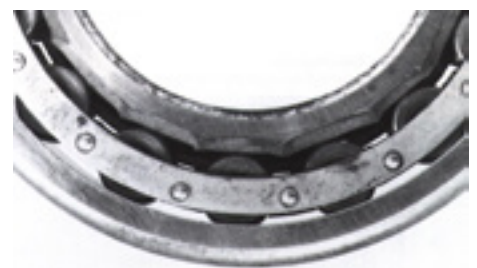
## INSTALLATION DAMAGE FAILURES

Occurs when a sharp impact is applied incorrectly to a bearing during mounting or dismounting. Installation damage often results in fracturing off pieces of a bearing. Again, review the installation technique and see if there needs to be tooling or process changes that minimize the risk. Lack of training for proper installation can contribute to the cause of damage.

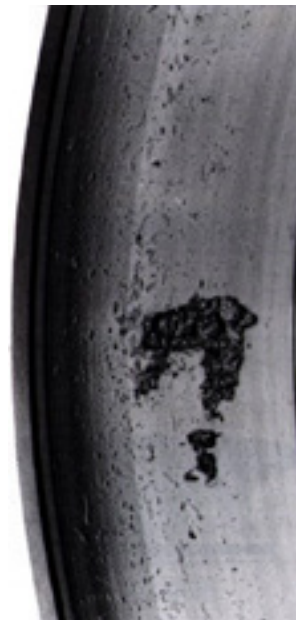
## CONTAMINATION FAILURES

Symptoms are dents or scratches embedded in the bearing raceways and balls/rollers resulting in bearings with high vibration and wear.

Principal sources are dirty tools, contaminated work areas, dirty hands and foreign matter in lubricant or cleaning solutions. Small pits form from contamination that with time and subsequent roller passes create larger areas of spalling. Investigate the storage and installation practices to make sure areas are clean. Make sure proper sealing is occurring on the unit to prevent ingress of damaging particles.

**Irregular dents or material embedded in raceways.**

**Balls will be similarly dented, dull, or scratched.**

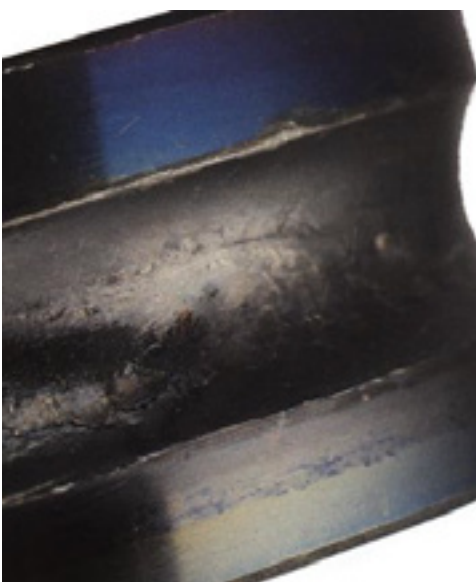
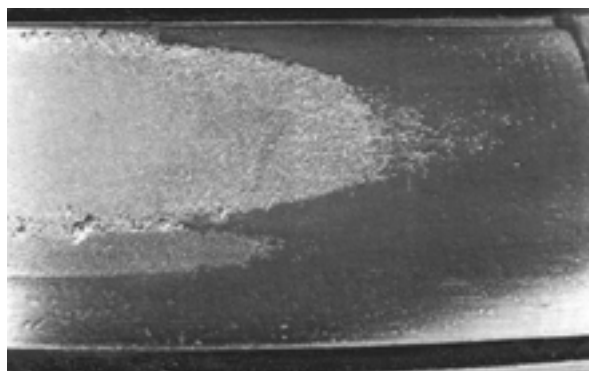
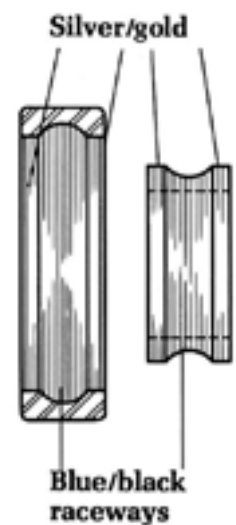
## LUBRICANT FAILURES

Symptoms include discolored raceways and balls/rollers.

Failures are typically caused by restricted lubricant flow or excessive temperatures that degrade the lubricant's properties.

Lubricant failure will lead to excessive wear, overheating and subsequent bearing failure.

**Balls will also be blue/black.**

Discoloration associated with tempering, along with micro-pitting damage, means the lubrication delivery needs to be reviewed. Look to see if the unit is starving the bearing of oil or determine if the oil viscosity is too thin.

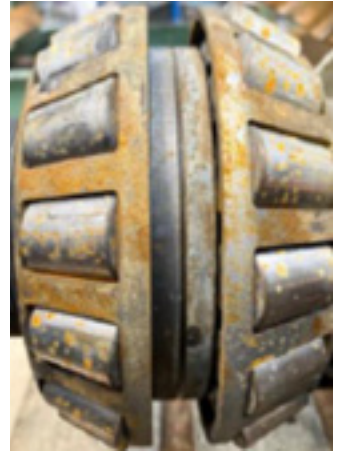
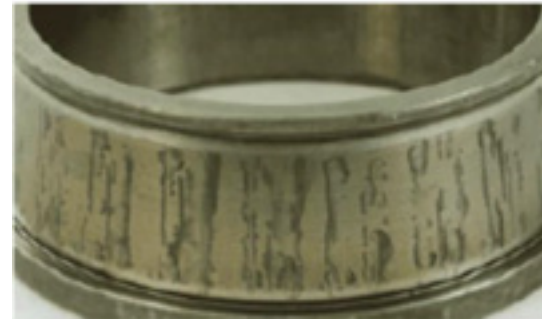
## CORROSION FAILURES

Symptoms include red/brown areas on rolling elements, raceways, and cages.

Corrosion usually results in increased vibration followed by wear, with subsequent increase in radial clearance or loss of preload.

Usually caused by contamination from water. Look for possible sources and try to eliminate. For example, for washdown requirements that may require a different seal design, for condensation—use a desiccant breather. Of course, there may be corrosive environments that have to be evaluated at the time of design to ensure components are protected from corrosion, which may include stainless steel components or the use of metal coating processes for protection.

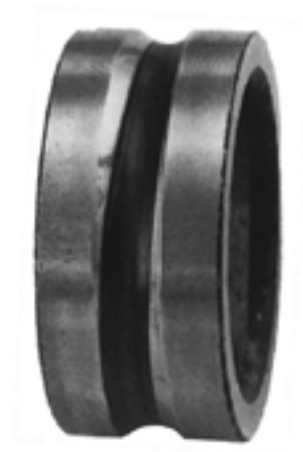
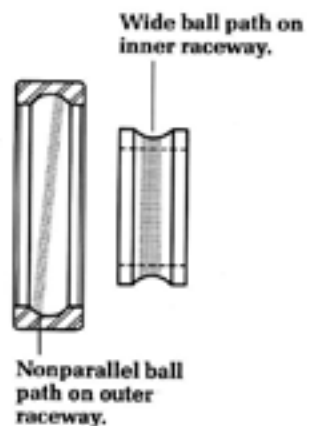
## MISALIGNMENT FAILURES

Can be detected on the raceway of the stationary ring by a rolling element wear path that is not parallel to the raceway edges. Excess misalignment can cause abnormal temperature rise and/or heavy wear in the cage pockets.

- bent shafts / misaligned housings
- burrs or dirt on the shaft or housing shoulders
- shaft threads that are not square with shaft seats
- locking nuts with faces that are not square to the thread axis

You can see roller paths that are at an angle which is evidence that the bearings are operating at an angle not perpendicular to the axis of rotation. You can consider bearing backing shoulders not being square, bent shafts, housing or shaft deflections. These are just a few areas to consider and evaluate. Some bearing designs handle misalignment better than others.

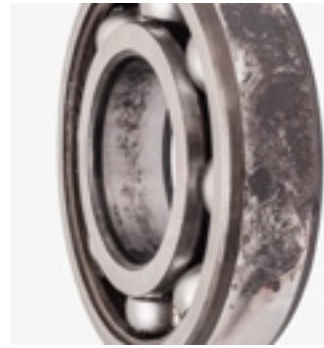
## FRETTING CORROSION

Normally occurs through outer race slippage in the housing due to improper fits. Discoloration and scoring will appear on the outside of the outer race.

**Outer ring slippage caused by improper housing fits.**

Look for an area that looks like it's been hammered and brown due to oxidation. Typically, either the outer race OD to housing bore fit is too loose or the inner race ID to shaft OD is too loose. The fits need to be evaluated and either fixed or redesigned to a more applicable fit.

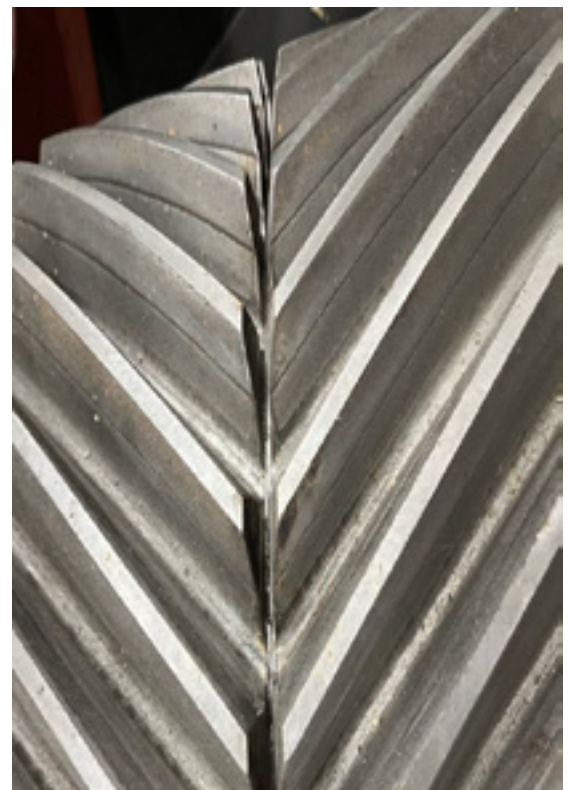
#### NORMAL WEAR

Normal wear is what you see occur over the life of a gear set. Visually you'll see on the flank of the tooth, smooth areas top and bottom and a defined line running along the flank at the pitch point where pure rolling takes place. Again, this should occur over many years if the unit is properly designed. If caught early enough and the damage is not too severe, the flanks can be reclaimed and the part be put back in service.

- Tooth flanks on sliding surfaces smooth out over time.
- Pronounced pitch line
- Normal wear does not influence the life and proper functioning of the gear train.

- Tooth flank surface has tall asperities making it rough but smooth out during operating life
- Viscosity of oil too low
- Sliding and rolling velocities of the tooth flanks are not sufficient to allow a cohesive lubricant film to be built up between the tooth flanks.

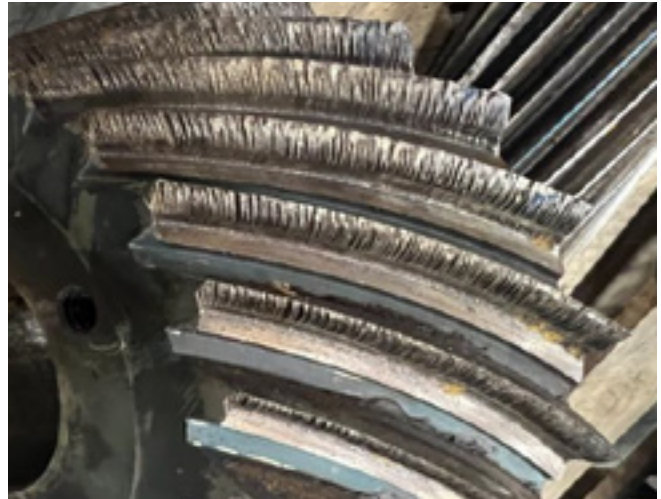
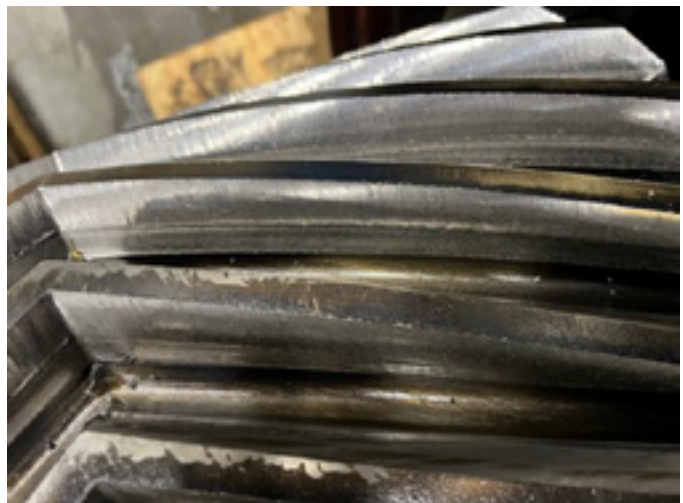
## ABRASIVE WEAR

This is when the wear occurs excessively and much quicker than intended. The tooth flanks exhibit a uniformly matte surface with radial scratches. Often a sharp edge of metal is present on the tip of the tooth's loaded flank. The original flanks are largely removed and you can feel the indentations in the tooth with your finger running up the profile. Operators need to review and evaluate recommended oil viscosity, oil temperature, oil cleanliness, age of the oil. Have the oil periodically tested. Determine if the load that is being transmitted matches the design load.

- The tooth flanks exhibit a uniformly matte surface exhibiting radial scratches.
- The original tooth flank surface is largely eliminated with increasing running time.
- At an advanced stage changes in the tooth profile form and an increase in backlash are detectable. A sharp edge usually forms on the tip of the tooth flanks

- Metal-to-metal contact of loaded surfaces
- Original oil recommendation is incorrect viscosity
- Viscosity of the oil changes
- High temperature
- Contaminated oil: water, dirt, metal
- Oil oxidized
- Excessive load

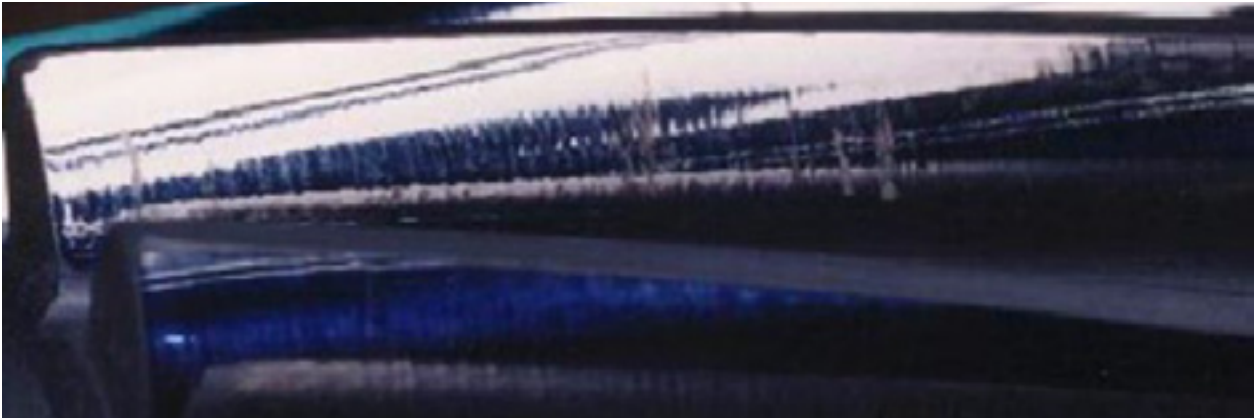
## **POLISHING WEAR**

Polishing is a special wear that is deceptive because of its lustrous appearance. It is created by very fine particles that lap the flanks of the teeth creating a shiny appearance. However, as this polishing takes place it degrades the involute profile of the tooth creating rough transmission between the mating parts. Make sure the oil is clean and filtered along with verifying it's the right viscosity.

- Fine-scale abrasion that causes gear teeth to have a bright mirror-like finish.
- The gear tooth surface may be smooth or wavy with local bumps.
- Looks nice but the tooth profile is being degraded. Acts as an aggressive and uncontrolled super finish.
- Under magnification the surface appears to be covered in fine scratches in the direction of sliding.
- This type of wear may reduce life if the profile of the tooth is damaged before the cause of the wear is eliminated.

- Promoted by chemically active lubricants that are contaminated with fine abrasives.

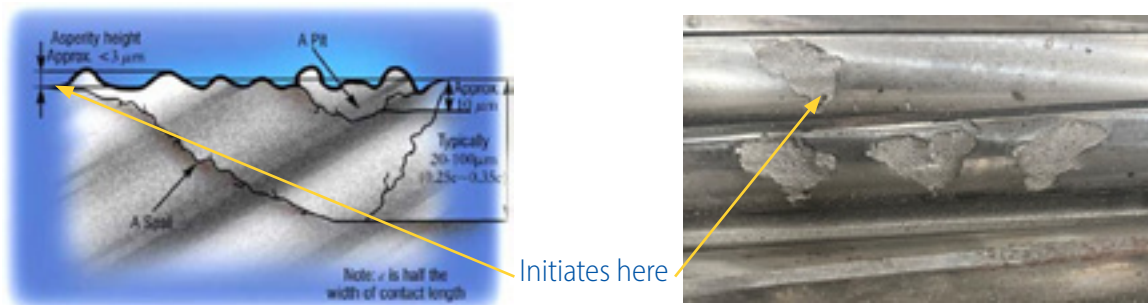
## SPALLING

Spalling consists of pits that initiate low in the tooth profile in the area of high sliding. Cracks initiate from the surface and moves inward. Review material certs for correct material and the heat-treating lab results and verify that hardness and case depth are correct. Review surface finish requirements and oil viscosity to make sure an adequate oil film is being produced. Make sure gear design doesn't introduce excessive sliding.

- Spall fatigue consists of pits that initiate low on the tooth profile from areas of high load and high sliding
- As the tooth slides through mesh areas of metal flake off or peel away usually in a triangular shape
- Crack initiates from the tooth surface and propagates inward

- Attributable to defective material or shortcomings in heat treatment
- Inadequate lubrication
- Overstressing of the core material. The thickness of the layers which break out is usually greater than the hardness depth
- Poor surface finish on tooth flanks

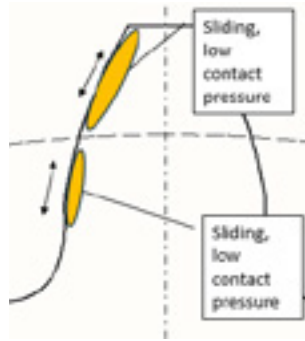
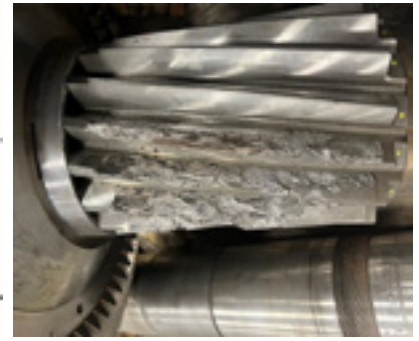
## SCORING DAMAGE

Scoring damage occurs when the combination of pressure, lubricant temperature, sliding velocity and friction cause the lube film to vaporize and the mating tooth surfaces weld together. As the parts rotate the welds tear apart leaving radial scratches along the tooth flanks. Proper lubricant and gear design need to be reviewed. Gear geometry changes, specified lubricant and surface finish requirements may all need to be modified

- Rough edge radial scratches

- Combination of pressure, lubricant temperature, sliding velocity and friction cause the lube film to vaporize and the mating tooth surfaces weld together.
- As the parts continue to rotate, the welded areas tear apart leaving radial scratch marks. Poor surface finish on tooth flanks

- Select proper lubricant for operating conditions and provide high-quality surface finish.
- Design with high sliding action should be avoided.

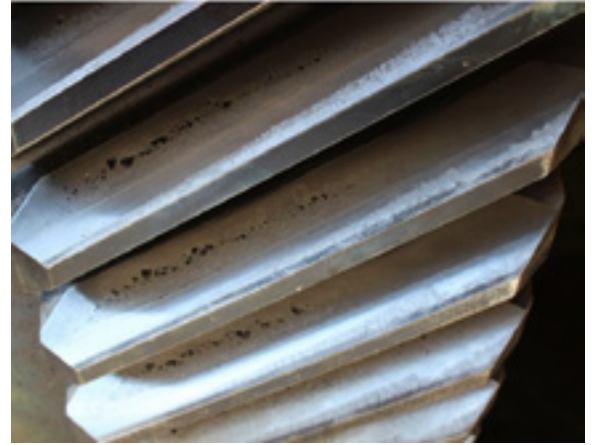
## INITIAL PITTING

Starts out in the mixed lubrication regime and transitions into the full EHL regime. Once that occurs the unit operates just fine.

- Taller asperities wear down during initial operation and eventually smooth over.
- Doesn't affect operational life
- Visual halo effect around the pits
- Usually a transition from partial lube film to full EHL

- Rough tooth flank surface
- Tooth inaccuracy (lead error)
- Internal misalignment
- Thin oil

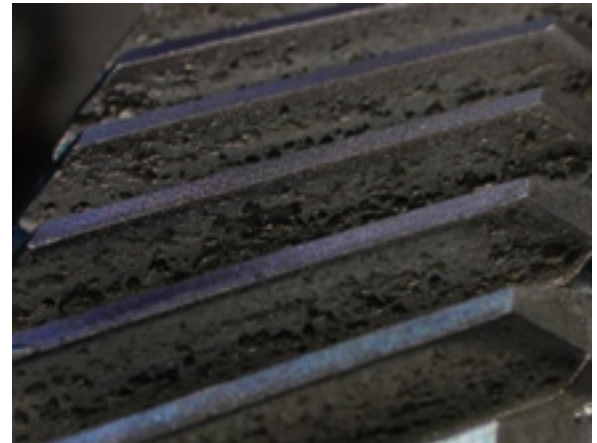
## DESTRUCTIVE PITTING, PROGRESSIVE PITTING

More pits reduce the area carrying the load which means the contact stress goes up even more. Pits grow to the point that cracks form between them and ultimately the cracks lead to a fracture. Tooth material may be too soft. Load may be too high. Oil viscosity too thin. All of them need to be investigated.

- Pitting continues to develop from initial pitting even after initial surface asperities on the tooth flank have been worn down
- Leads to the formation of larger pits through the disruption of material from adjacent smaller pits.
- Self-propagating in that with each pit that forms there is less surface area on the tooth flank to carry the load creating more pits
- Rough surface impedes smooth transfer of load accelerating removal of material
- Continual removal of material can lead to tooth fracturing

- Metal-to-metal contact due to asperities taller than oil film thickness
- Soft material's endurance limit being exceeded as teeth roll through mesh
- Excessive load
- Oil viscosity too thin – wrong grade, too hot, oxidized oil, contaminated oil

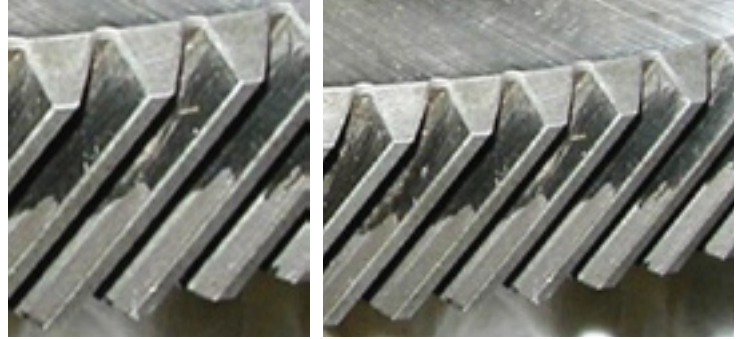
## MICRO-PITTING

Micro-pitting is similar to macro-pitting; micro-pitting originates from the same reasons— low oil film and tall asperities. This just happens to be damage you see in carburized teeth. This damage shown in the picture would lead you to question the alignment. You only see half of the tooth face carrying load. With proper alignment this damage may not have occurred.

- Micro-pitting gives the gear tooth a “frosted, or gray stained” appearance.
- Under magnification, the surface appears to be covered by very fine pits that are usually cover a large area but very shallow in depth.
- Micro-pitting is typical phenomenon for surface hardened gear teeth.
- The depth of cracks is typically in the 5-10µm range

- Asperity contact issue. Lubrication and surface roughness have the biggest influence for the situation.
- In addition, the same causes of macro-pitting may be valid.

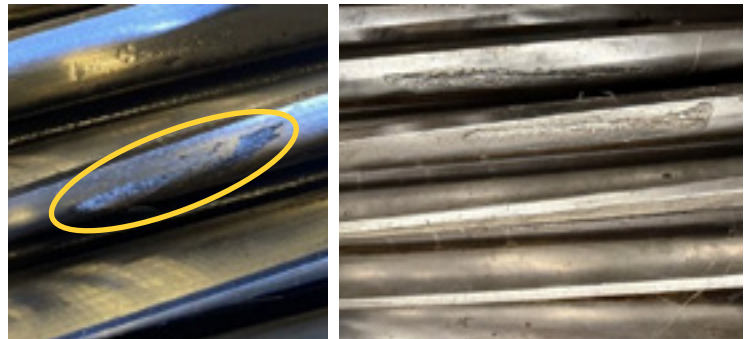
## CASE CRUSHING

Case crushing can be attributed to thin case depth, weak core strength due to bad material, or overload. Bottom picture you can see signs of tempering that would have softened the case. These pictures would justify verifying the alignment and calculating the deflection based on the shorter contact area. Material certs and carburizing records need to be reviewed for proper heat treatment.

- Metal removal near the pitch line
- Usually shallow and covers a larger area

- Case depth too shallow and allowing the endurance limit of the softer core to be exceeded.
- Case depth may be okay but loading may be excessive
- Inferior material that creates a softer core hardness
- High temperatures temper and soften the steel

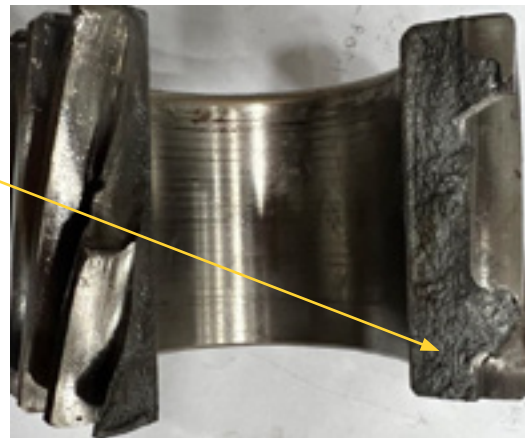
Instantaneous fracture (brittle) granular

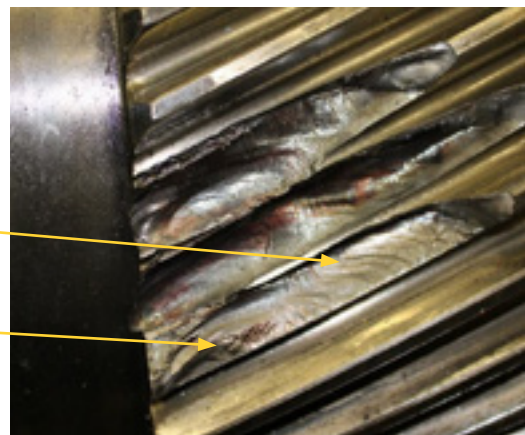
Notice fatigue beach mark (cyclic) fracture surface

Initiation

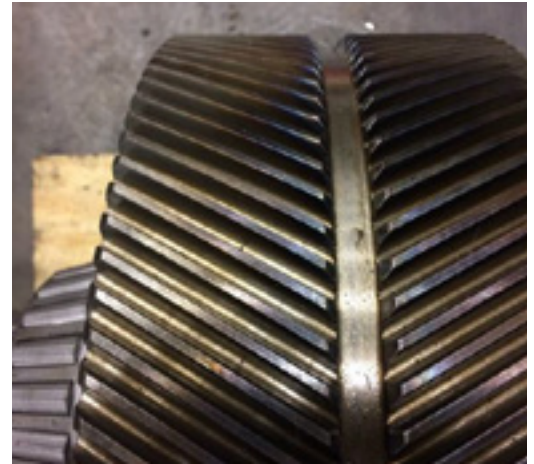
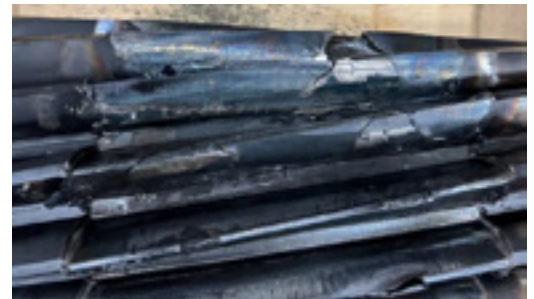
## OVERHEATING LEADS TO FAILURE

Overheating shows evidence of tempering of the material as exhibited by the color change. Extreme cases show deformation of the teeth and cracks. Softer material can't carry the forces, so the teeth fail. Investigate the oil delivery.

- Symptoms are discoloration of the gear teeth from gold to blue.
- Excessive temperatures can anneal the teeth and make them soft.
- Extreme cases show deformation of the teeth and fractures
- Consider oil level or low oil pressure as the cause

Did the oil pump fail? Oil level too low? Stopped up spray ports?

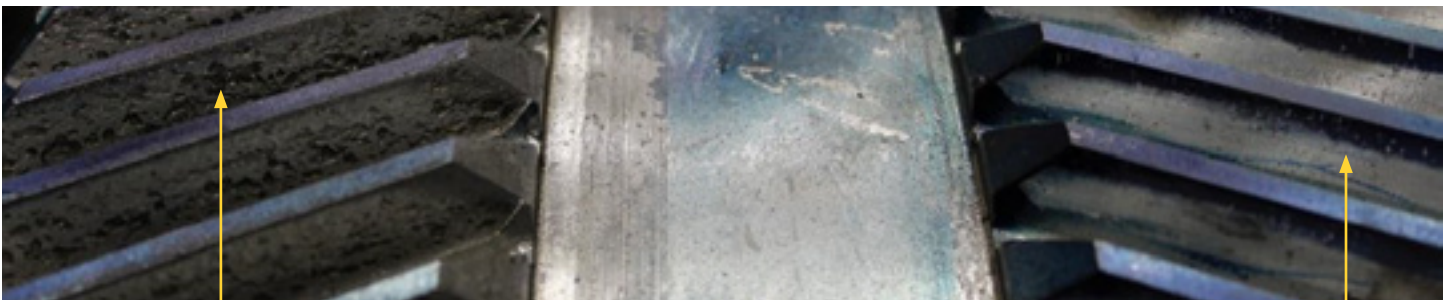
## PITTING MAY OCCUR DUE TO AXIAL MISALIGNMENT

Axial misalignment. This double helical gear only ran on a single helix. They are designed so that one of the mating parts is able to float and center up in the mesh so the load is evenly distributed. In this case it should be investigated to see why the mating pinion did not run centered up on the gear. Wrong coupling gap? Over-greased coupling? Floating bearing was held? Proper axial alignment would have most likely prevented this failure.

Destructive pitting on the left helix

No pitting on the right helix

- If caught soon enough, eliminate the thrust and the pitting may stop and even heal itself

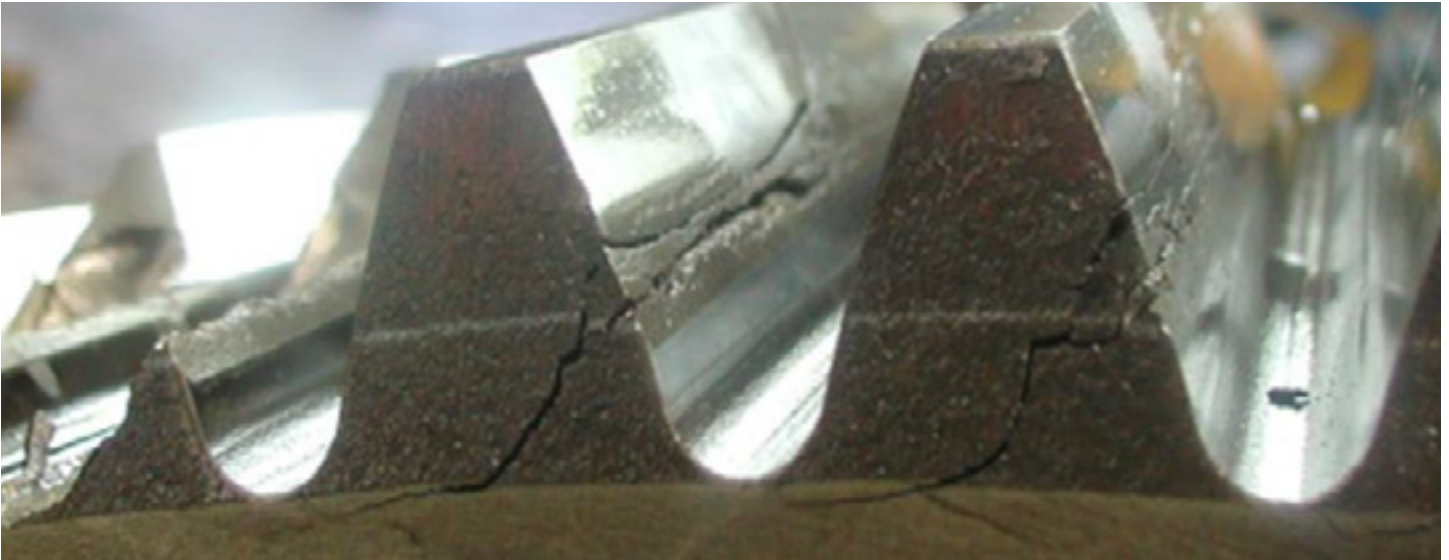
## CAUSES OF FRACTURES

The picture depicts that the gear was poorly aligned with the pinion. That overloaded the teeth and it started pitting. The pits propagated toward one another through flexural bending and formed a crack. Just a matter of time before the cracks would have caused the teeth to fracture and deposit broken tooth debris in the mesh creating a catastrophe. Evaluate the gearbox alignment and shaft deflection to determine what to change to eliminate the poor contact.

- Poor load distribution overloaded the flank
- Overload caused pitting
- Pits connect creating a crack that typically leads to tooth fracture.
- This was caught before tooth separation.
