PROBLEM & SOLUTION

- Industry:** Food & Beverage
- Application:** Beverage Conveyor
- Result:** Reduced Energy Cost by 30% & Fixed Leakage
- Products Used:** Hyponic® Gearmotor

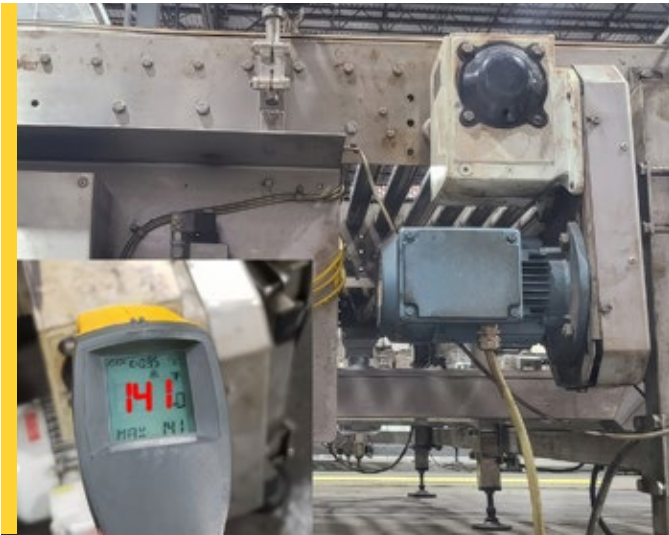
A popular beverage producer was complaining about the **short lifespan** of the **worm gearbox** they had installed.

With this competitor's unit, the **input shaft** was located **below the output shaft**. Because of the loading of the belt, the input seal and bearing **failed constantly**, resulting in **unsafe puddles of oil** on the shop floor.

This configuration of this worm gearbox was also **highly inefficient**, creating the risk of a **burn hazard** for employees.

Our **grease-filled, maintenance-free Hyponic®** gearbox **eliminated the oil leakage** problem.

Due to its **30% increase in efficiency**, our gearbox also ran **40 degrees cooler**, **eliminating** the burn hazard.
