08FTM02

A Methodology for Identifying Defective Cycloidal Reduction Components Using Vibration Analysis and Techniques

By V. Cochran and T. Bobak,
Sumitomo Drive Technologies

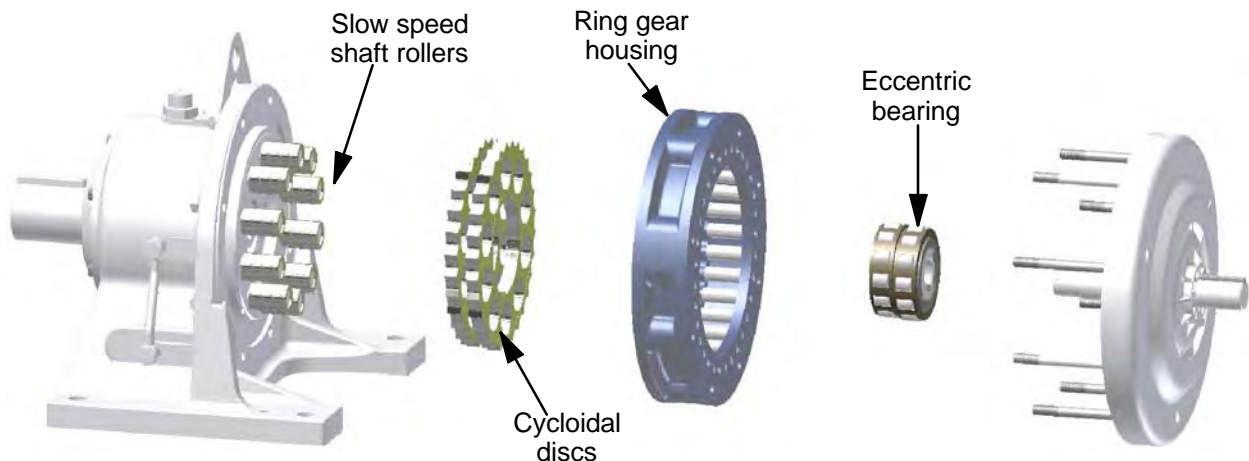
Figure 1. Exploded view of cycloidal reduction components

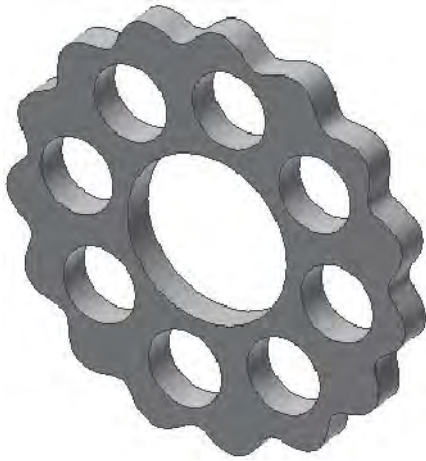
Figure 3. Cycloidal disc

A cycloidal eccentric bearing presents an uncommon case since both bearing races rotate. Cycloidal discs mesh with pins or rollers located along the inner perimeter of the ring gear housing. As the discs and the pins (or rollers) mesh, a contact frequency is created which can be monitored. See figures 2 - 4. The user can calculate the cycloidal disc mesh frequency by using:

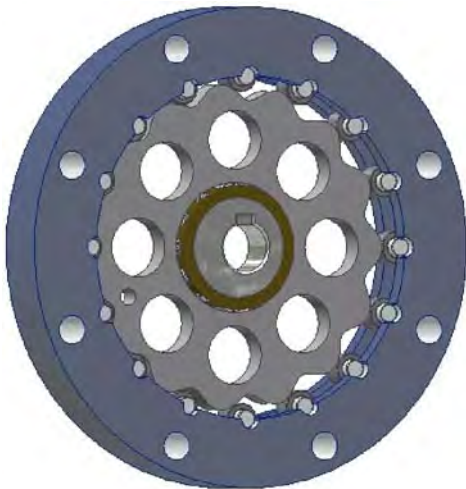
Figure 4. Cycloidal disc meshes with pins or rollers

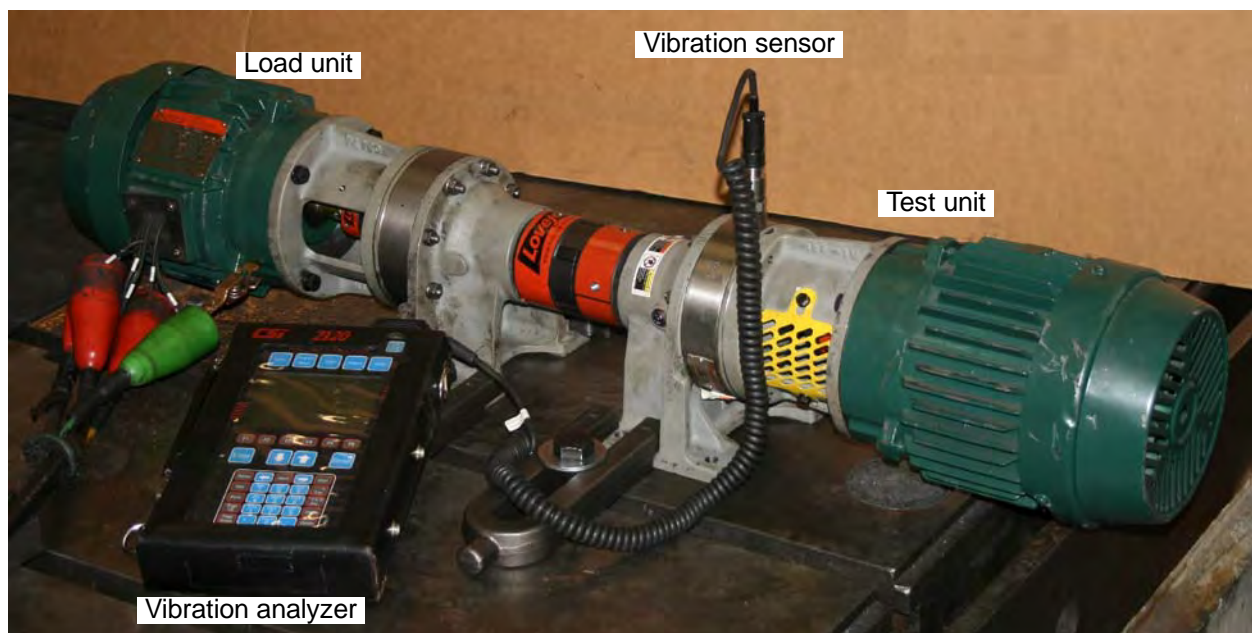
A new, identical unit was assembled in order to obtain a baseline measurement. After obtaining the baseline with a vibration data collector as shown in figure 5, the new unit's eccentric bearing, cycloidal discs, and ring gear assembly were exchanged for those from the damaged unit in a progressive manner in order to simulate the progression of typical wear. If a unit's eccentric bearing becomes worn and the unit continues to operate, wear progresses to the cycloidal discs. Further operation leads to wear within the ring gear assembly. The wear's progression is due to the flow of metallic particles between the internal components by way of the lubricant.

Figure 5. Vibration measurement set-up

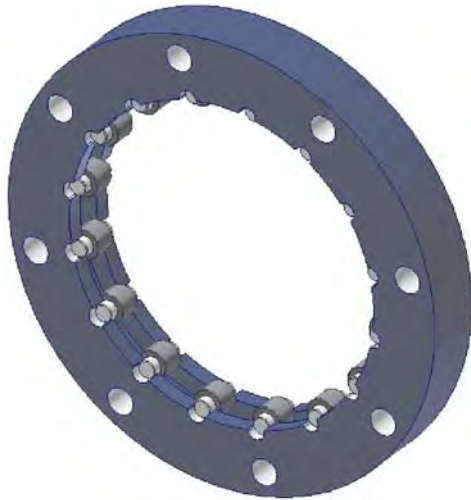
6. With the worn eccentric bearing and discs in the new unit, the returned unit's ring gear assembly was installed, see figure 6. The new unit's vibrations were measured to obtain data showing the final level of progressive cycloidal failure – eccentric bearing failure combined with disc and ring gear assembly damage.

Figure 6. Cycloidal ring gear assembly

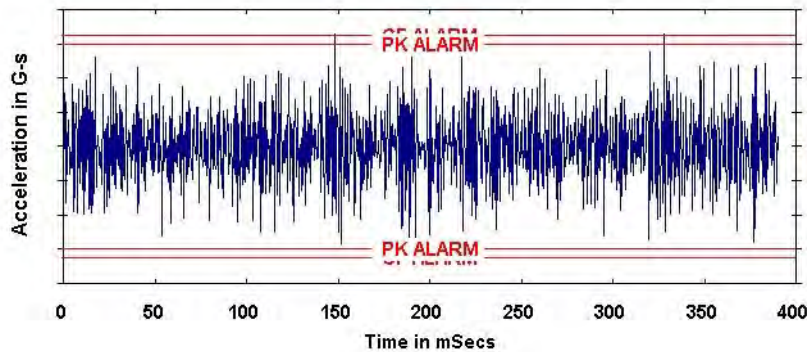
Figure 8. Waveform - returned unit

Each figure has a corresponding one among figures 8 – 13. The comparison of figure 14 with figure 8

shows that the returned unit creates much higher acceleration values than the new one. Clearly, something in the returned unit has changed. Figure 15 vs. figure 9 and figure 16 vs. figure 10 reveal amplitude increases and sidebands at the higher frequencies. These changes suggest defective elements among the cycloidal reduction components. The same effects are noted when the components are evaluated by comparing figures 17 – 19 against figures 11 – 13. These observations signal that some amount of wear has occurred to all of them.

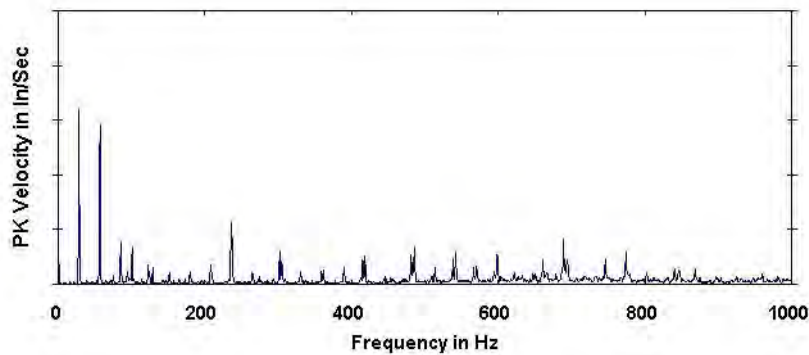
Figure 9. Velocity frequency graph - returned unit

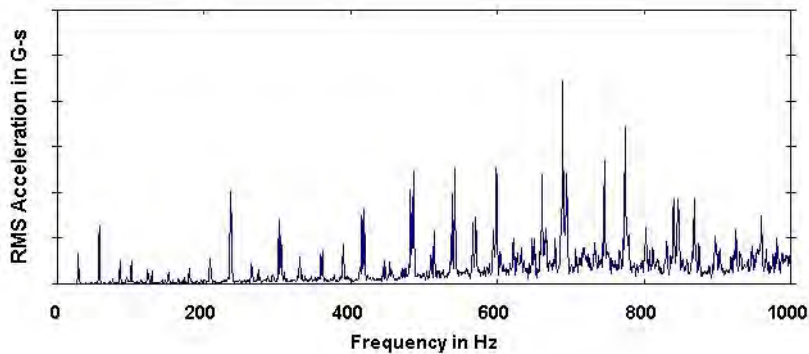
An evaluation of the vibrations in more detail, however, reveals areas of concern. In figure 10 we see the acceleration frequencies. The presence of peaks at the higher frequencies indicates there may be roller bearing problems. Sidebands accompanying these peaks are another indication. At this point, the operating frequencies of the eccentric bearing should be examined.

Figure 10. Acceleration frequency graph - returned unit

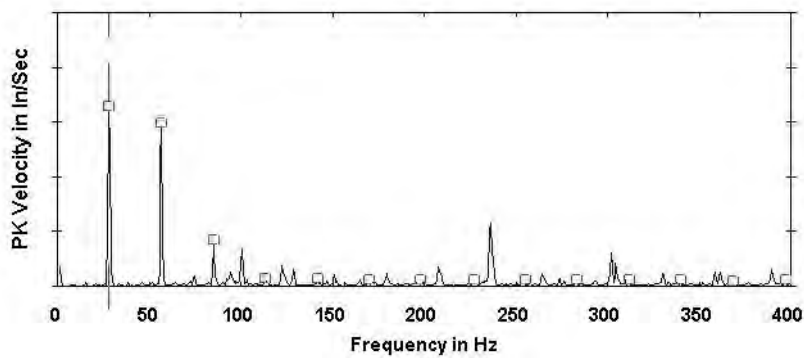
The velocity frequencies were accessed with the vibration analysis software and the cursor was placed around 29 Hz, the eccentric bearing cam frequency. Figure 11 shows the result. The peak velocity occurs at that frequency, and its second harmonic is not much less.

Figure 11. Eccentric bearing cam frequency graph - returned unit

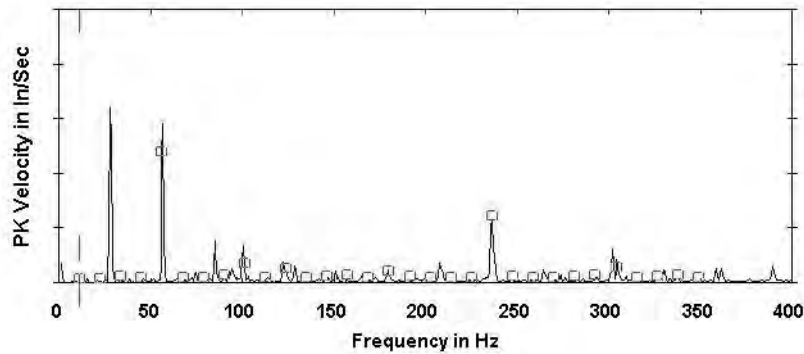
The cursor was next placed around 11.20 Hz, the eccentric bearing's FTF, to check for eccentric bearing roller faults. Many harmonics were discovered, with the higher ones having sidebands. See figure 12 below.

Figure 12. Eccentric bearing rollers frequency graph - returned unit

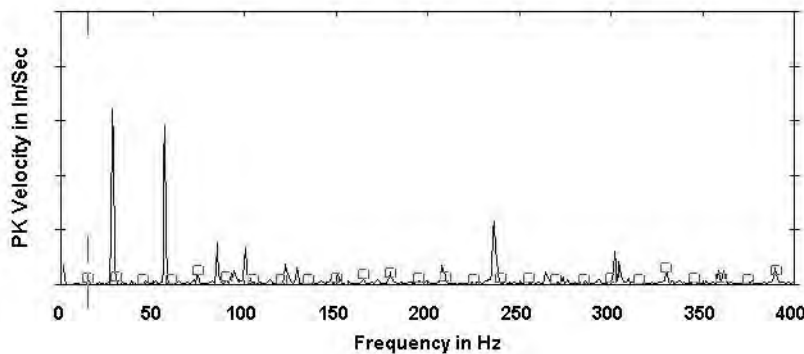
Finally, the cycloidal disc mesh frequency of 14.75 Hz was checked. Figure 13 shows that harmonics are present, but their velocity levels are low.

Figure 13. Cycloidal disc mesh frequency graph - returned unit

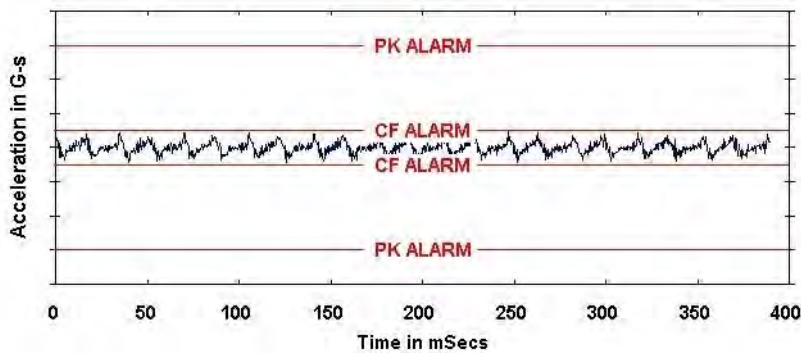
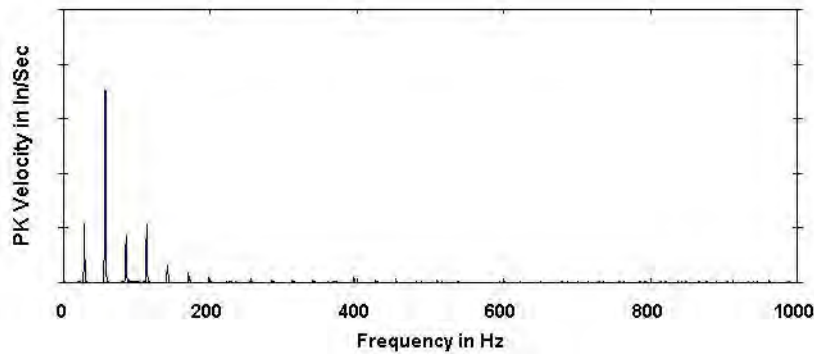
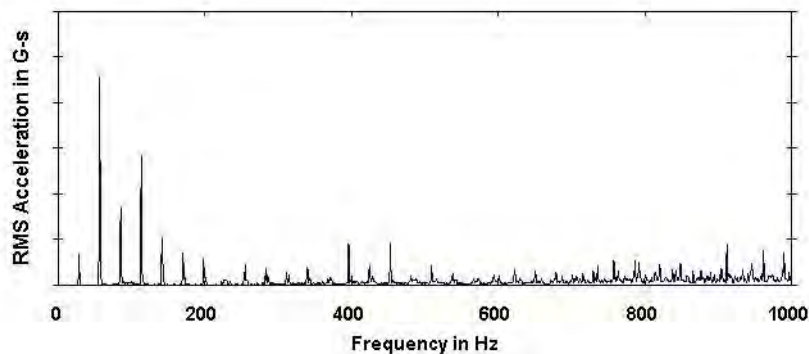
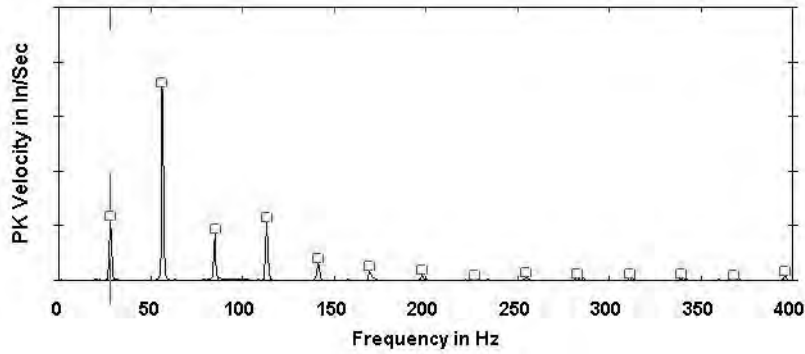
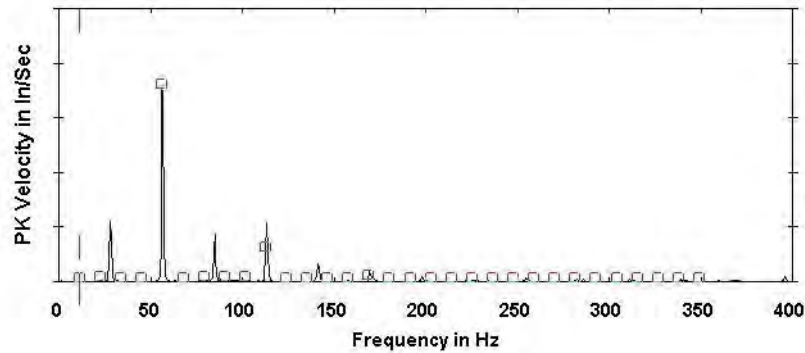
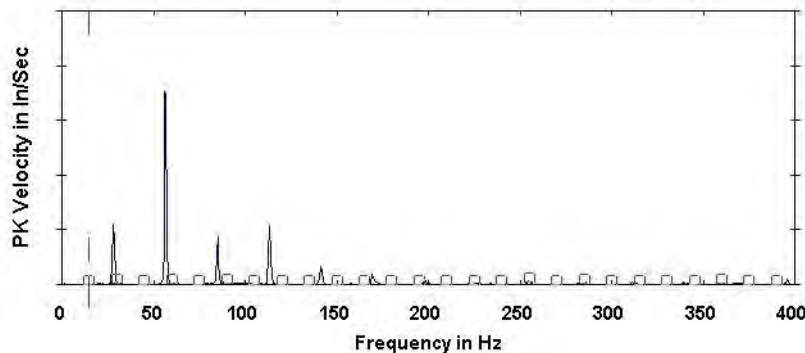
Figures 14 – 19 show a baseline recorded from the new unit. If customers record such a baseline immediately after installing a unit, then future measurements can be compared to it so that wear can be detected before catastrophic failure occurs. This is especially useful in noisy environments, where machine component noise can be difficult to differentiate.

Figure 14. Waveform - new unit

Figure 15. Velocity frequency graph - new unit

Figure 16. Acceleration frequency graph - new unit

Figure 17. Eccentric bearing cam frequency graph - new unit

Figure 18. Eccentric bearing rollers frequency graph - new unit

Figure 19. Cycloidal disc mesh frequency graph - new unit

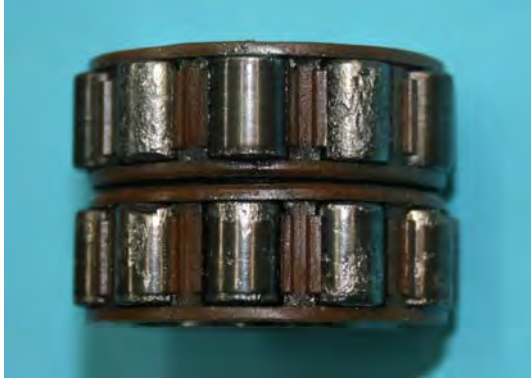
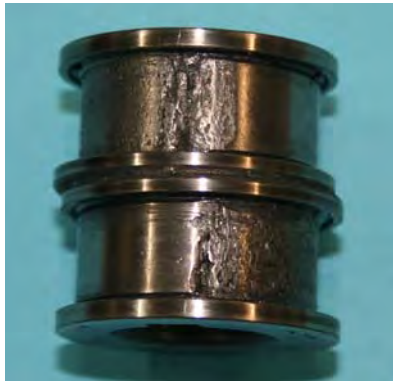
In an overloaded or inadequately lubricated condition, the reducer will overheat. Undetected, the overheating causes lubrication failure and discoloration of the bearing elements. Pitting, which progresses to flaking and sometimes spalling, results shortly thereafter. Figure 20 shows the appearance of the worn eccentric bearing that was removed from the returned unit.

a) Eccentric bearing rollers

b) Eccentric bearing cam

Figure 20. Eccentric bearing damage due to overload or inadequate lubrication

Wear of the eccentric bearing will begin with pitting. See figure 20b. As the pits become more numerous, an increase in higher frequency amplitudes will be observed when a frequency measurement graph is compared to the reducer's baseline measurement. Sidebands around these higher frequencies will become apparent as well. At this stage of wear, the unit remains operational.

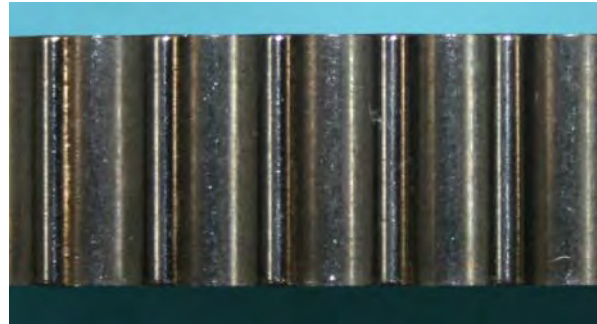
returned unit suffered such damage, as shown in figure 21. Additionally, the ring gear assembly components will suffer wear. Figures 22 – 24 illustrate the Micropitting and abrasion that occurred to the returned unit's components.

Figure 22. Micropitting of the cycloidal disc lobes

released by the eccentric bearing will flow between the internal reduction components via the lubricant. Indentations will be created in the cycloidal discs' center holes, as shown in figure 21. Figures 22 and 23 show the micropitting that will be experienced by the cycloidal discs' lobes and the ring gear pins. Figures 37 – 48, however, demonstrate that the wear of these components contributes no significant frequency amplitude increases to the frequency measurement graphs.

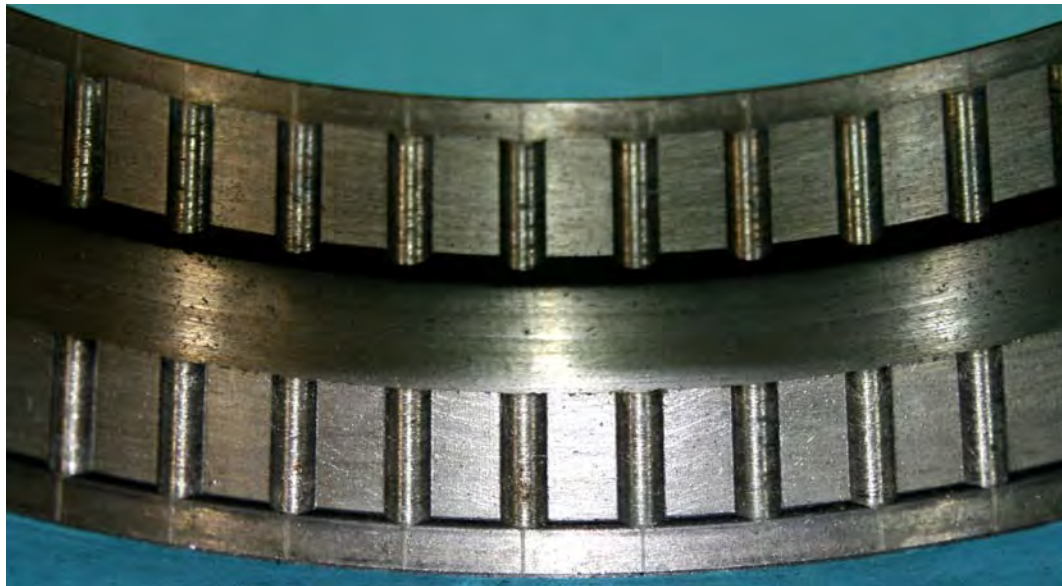
Figure 24. Mild abrasion in the ring gear pin bores

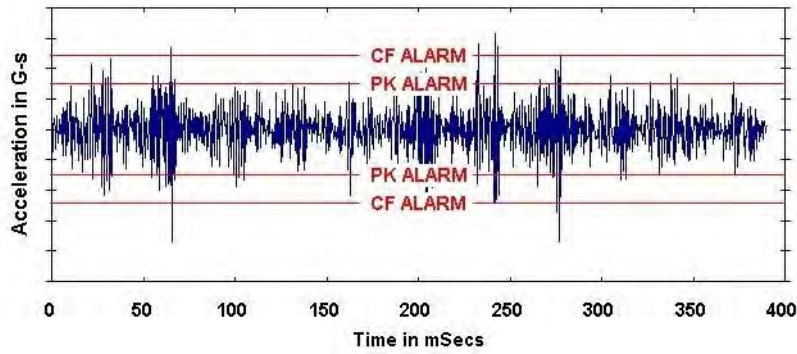
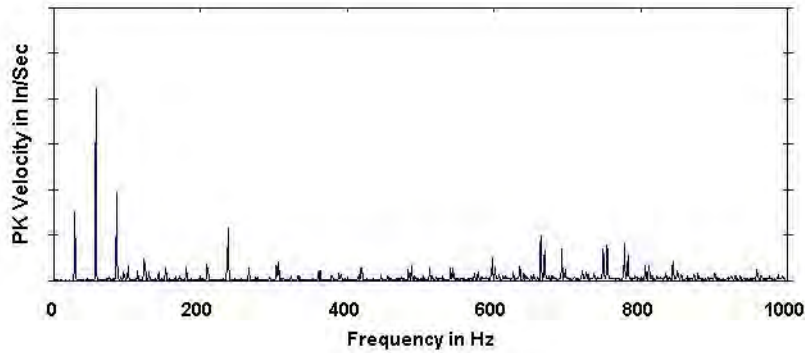
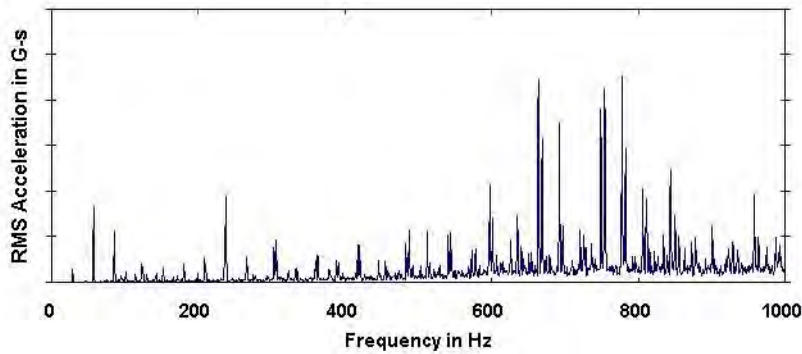
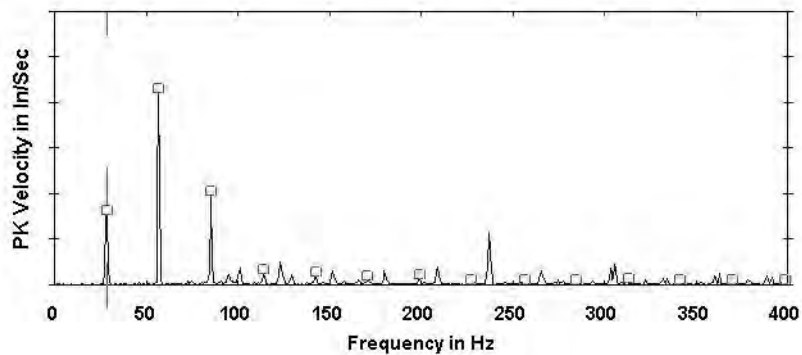
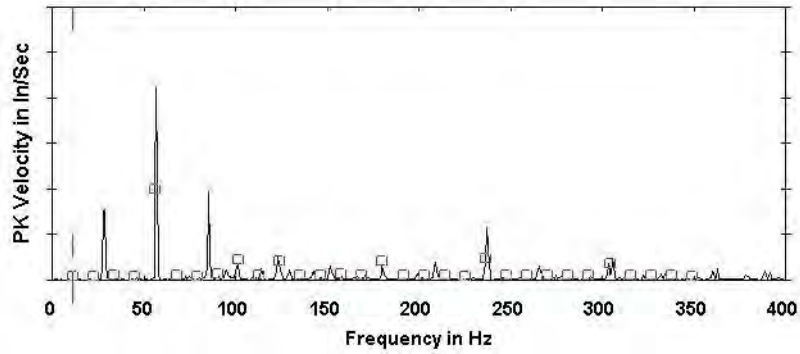
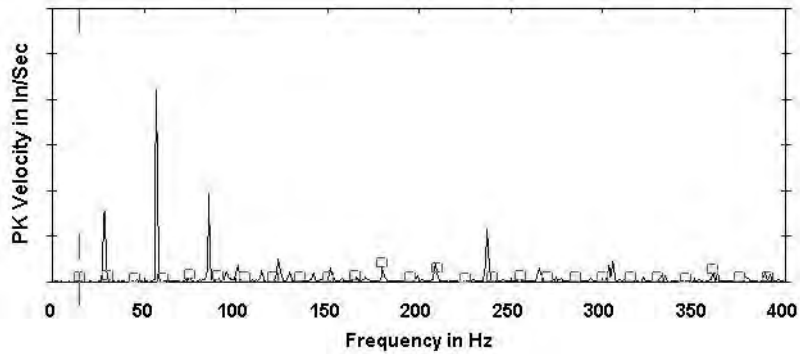
As described in steps 4 – 6 of the testing procedure, the worn components were substituted into the new unit in a manner that follows the progression of internal wear. Figures 25 – 30 were obtained after the new unit's eccentric bearing was replaced with the worn unit's eccentric bearing. Increases in all of the frequency amplitudes are noticeable.

Figure 25. Waveform - new unit with the worn eccentric bearing; see figures 8 and 14 for comparison

Figure 26. Velocity frequency graph - new unit with the worn eccentric bearing; see figures 9 and 15 for comparison

Figure 27. Acceleration frequency graph - new unit with the worn eccentric bearing; see figures 10 and 16 for comparison

Figure 28. Eccentric bearing cam frequency graph - new unit with the worn eccentric bearing; see figures 11 and 17 for comparison

Figure 29. Eccentric bearing rollers frequency graph - new unit with the worn eccentric bearing; see figures 12 and 18 for comparison

Figure 30. Cycloidal disc mesh frequency graph - new unit with the worn eccentric bearing; see figures 13 and 19 for comparison

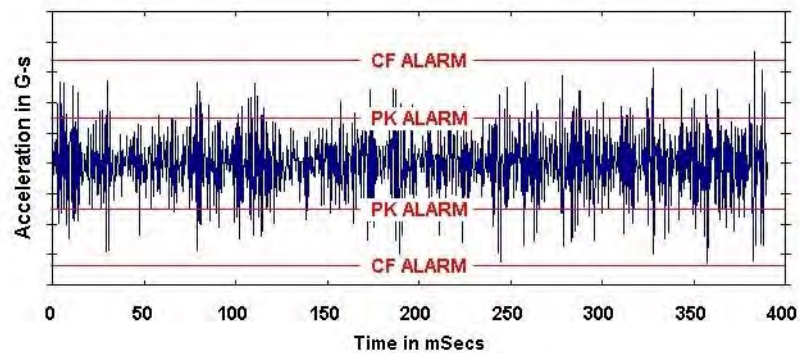
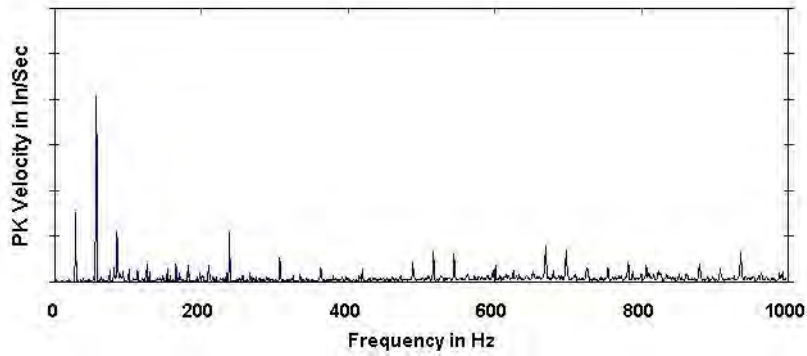
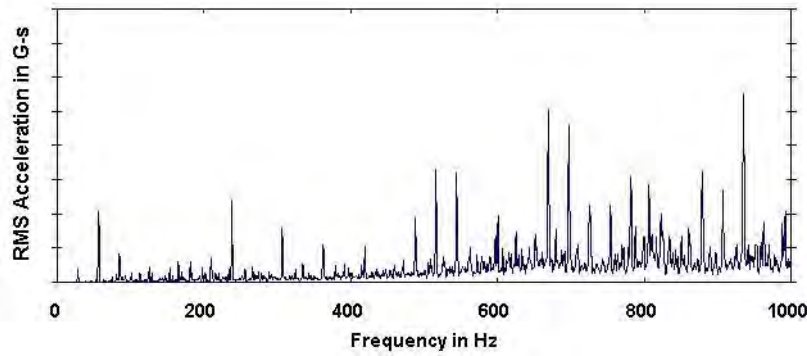
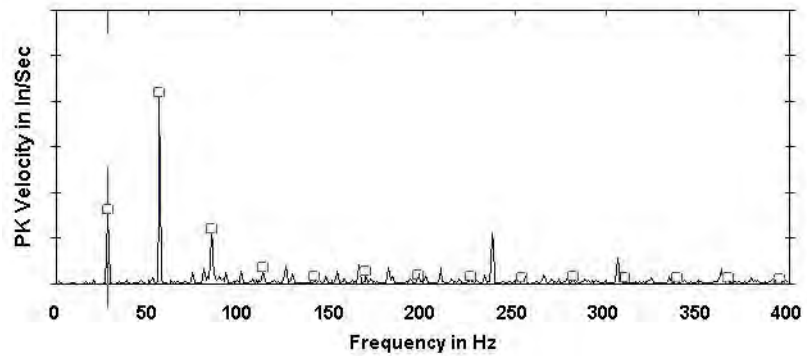
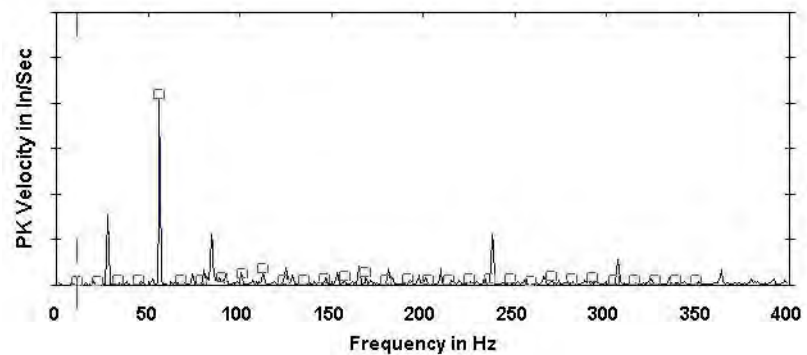
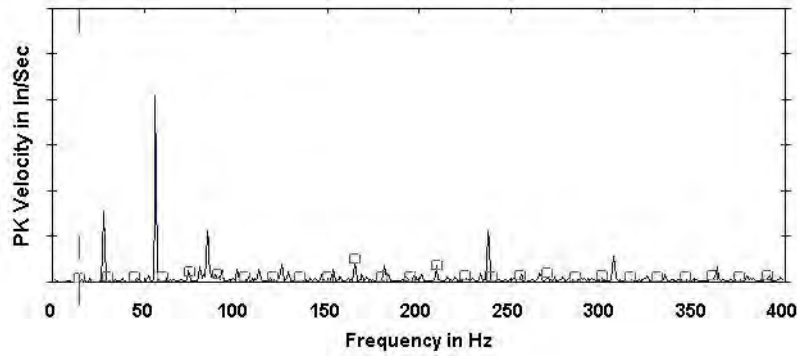
Next, the new unit was opened and the new discs were exchanged for the discs from the worn unit. The subsequent measurements are provided in figures 31 - 36. Note that frequency amplitudes increased above those in figures 25 - 30, but the increases weren't as dramatic as those created by the eccentric bearing alone. Figures 8 - 13 represent

Figure 31. Waveform - new unit with the worn eccentric bearing and worn cycloidal discs; see figure 25 for comparison

Figure 32. Velocity frequency graph - new unit with the worn eccentric bearing and worn cycloidal discs; see figure 26 for comparison

Figure 33. Acceleration frequency graph - new unit with the worn eccentric bearing and worn cycloidal discs; see figure 27 for comparison

Figure 34. Eccentric bearing cam frequency graph - new unit with the worn eccentric bearing and worn cycloidal discs; see figure 28 for comparison

Figure 35. Eccentric bearing rollers frequency graph - new unit with the worn eccentric bearing and worn cycloidal discs; see figure 29 for comparison

Figure 36. Cycloidal disc mesh frequency graph - new unit with the worn eccentric bearing and worn cycloidal discs; see figure 30 for comparison

the final stage in the wear progression, which includes the ring gear assembly. They are very similar to figures 31 - 36. Due to their similarity, procedures 9 and 10 were performed in order to determine what contributions the cycloidal discs and the ring gear assembly made to the vibration measurements.

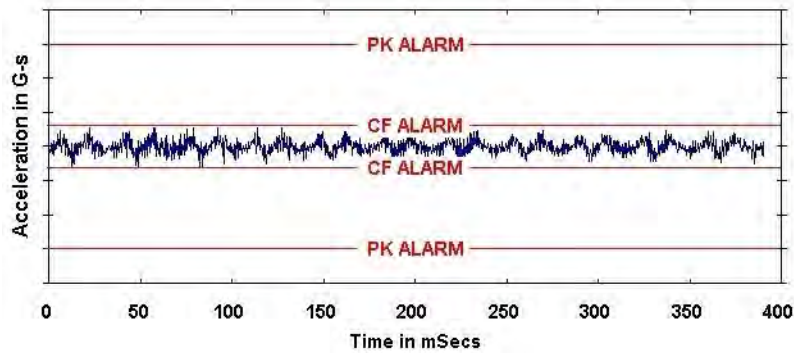
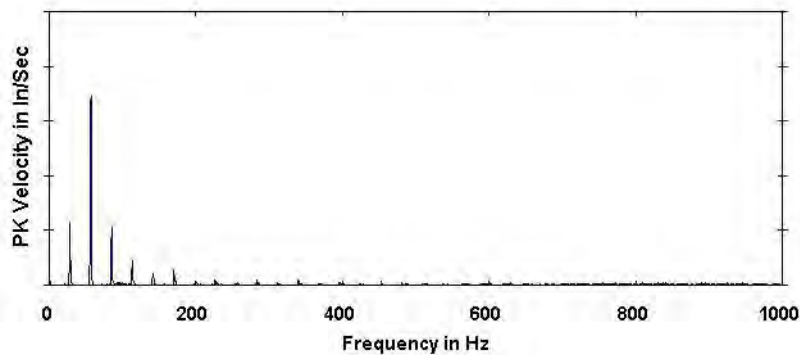
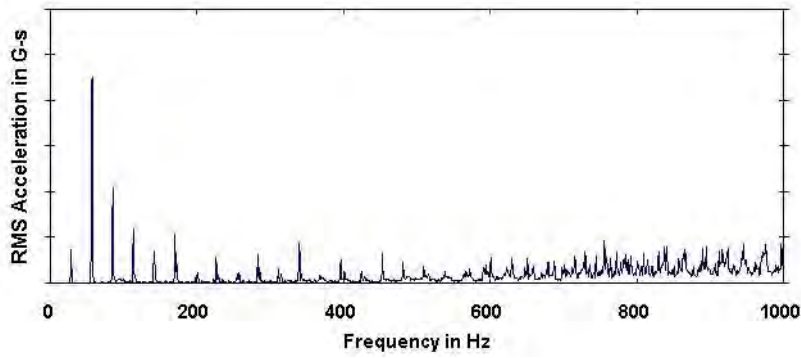
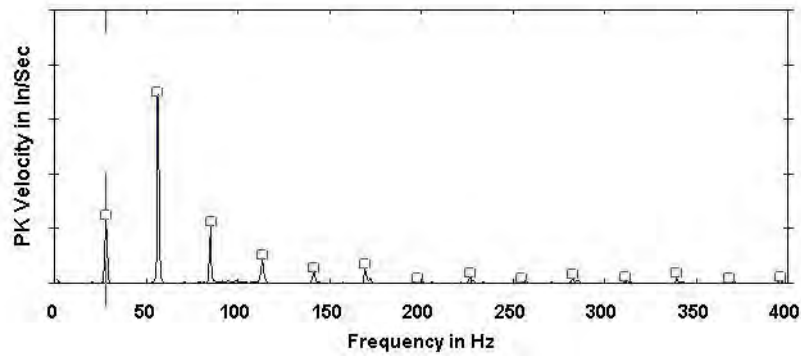
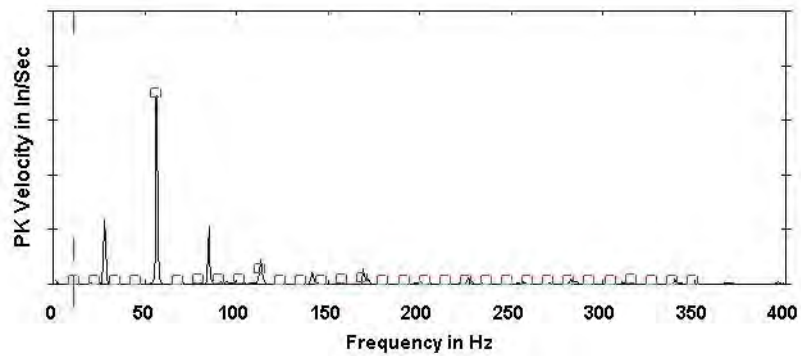
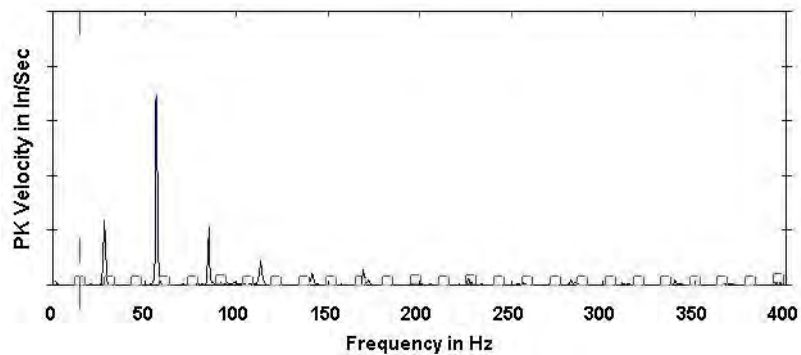
The new eccentric bearing was returned to the new unit while the worn cycloidal discs remained installed, according to step 9. The results are presented in figures 37 – 42. Additional disturbance can be seen in the waveform when figure 37 is compared to figure 14, but the waveform that was presented after the unit was newly assembled (all new components) is still recognizable. A compari-

son of the corresponding acceleration frequency graphs, figure 39 vs. figure 16, reveals minor amplitude increases at the higher frequencies. There are no discernable amplitude increases in any of the velocity frequency graphs. For example, figures 41 and 42 are indistinguishable from figures 18 and 19, respectively.

Figure 37. Waveform - new unit with the worn cycloidal discs; see figure 14 for comparison

Figure 38. Velocity frequency graph - new unit with the worn cycloidal discs; see figure 15 for comparison

Figure 39. Acceleration frequency graph - new unit with the worn cycloidal discs; see figure 16 for comparison

Figure 40. Eccentric bearing cam frequency graph - new unit with the worn cycloidal discs; see figure 17 for comparison

Figure 41. Eccentric bearing rollers frequency graph - new unit with the worn cycloidal discs; see figure 18 for comparison

Figure 42. Cycloidal disc gear mesh frequency graph - new unit with the worn cycloidal discs; see figure 19 for comparison

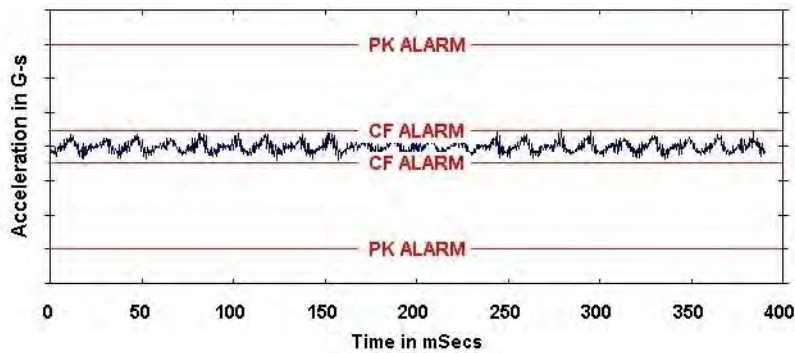
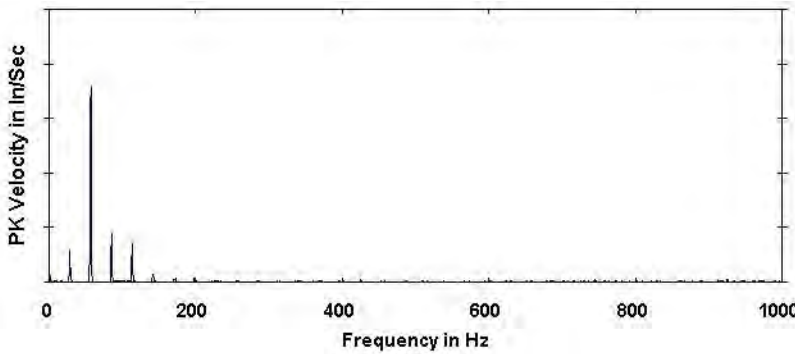
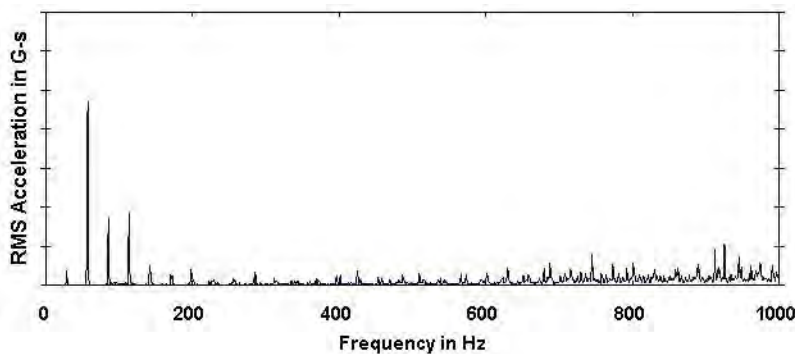
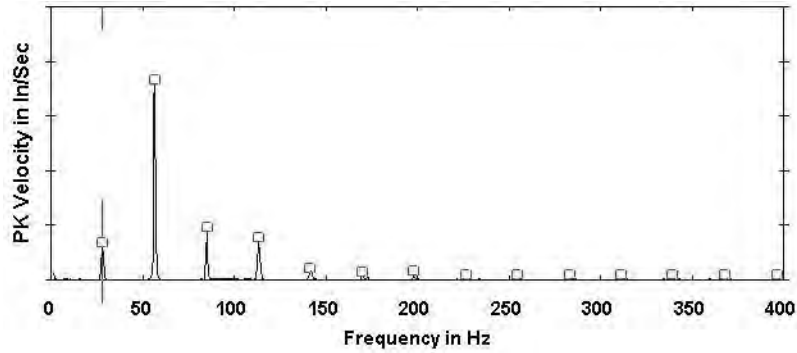
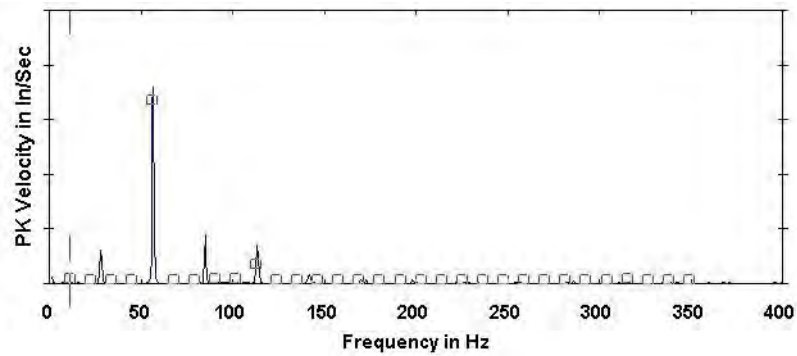
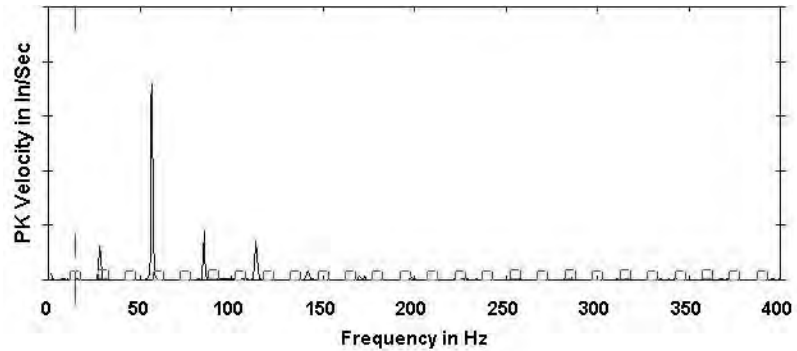
To conclude the tests, the new cycloidal discs were reinstalled in the new unit while its new ring gear assembly was exchanged for the worn one. Figures 43 – 48 show the measurements. A comparison of figure 43 against figure 14 shows a smaller disturbance than in figure 37, and the waveform that was presented after the unit was newly assembled is more recognizable. There is no significant difference between the acceleration frequency graphs in figures 45 and 16. As with the previous component arrangement, there is no noticeable difference in

the cycloidal disc mesh frequency amplitudes between the new and worn ring gear assemblies. Refer to figures 48 and 19.

Figure 43. Waveform - new unit with the bad ring gear assembly; see figure 14 for comparison

Figure 44. Velocity frequency graph - new unit with the worn ring gear assembly; see figure 15 for comparison

Figure 45. Acceleration frequency graph - new unit with the worn ring gear assembly; see figure 16 for comparison

Figure 46. Eccentric bearing cam frequency graph - new unit with the worn ring gear assembly; see figure 17 for comparison

Figure 47. Eccentric bearing roller frequency graph - new unit with the worn ring gear assembly; see figure 18 for comparison

Figure 48. Cycloidal disc mesh frequency graph - new unit with the worn ring gear assembly; see figure 19 for comparison

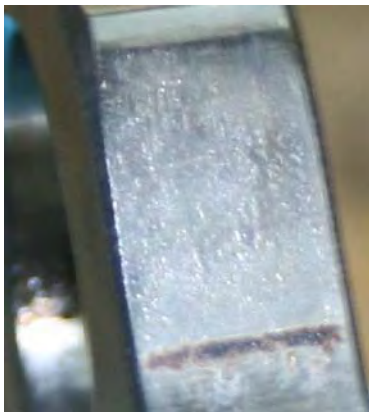
Figure 49. A micropitted disc

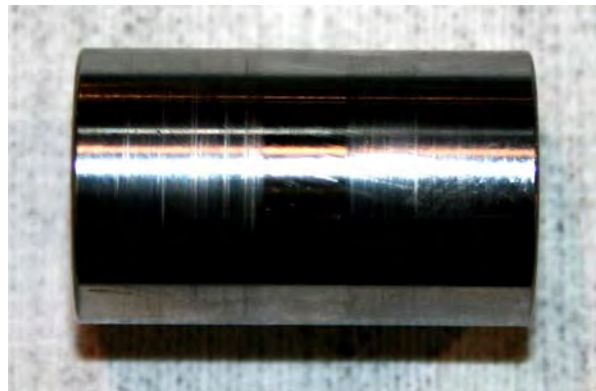
Figure 50. A mildly scuffed slow speed roller

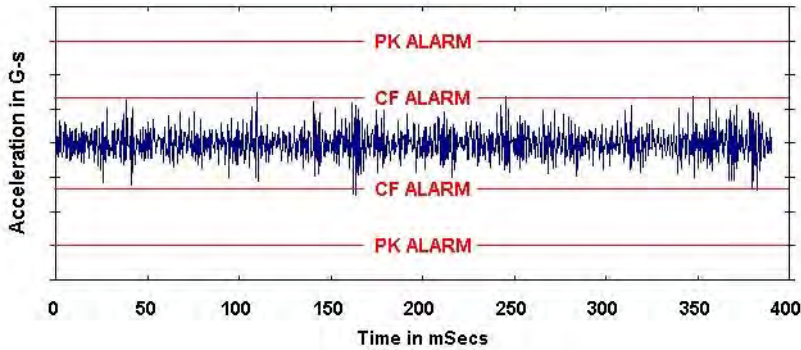
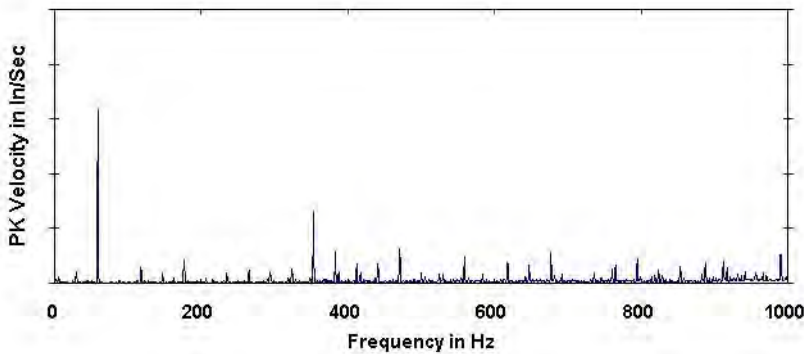
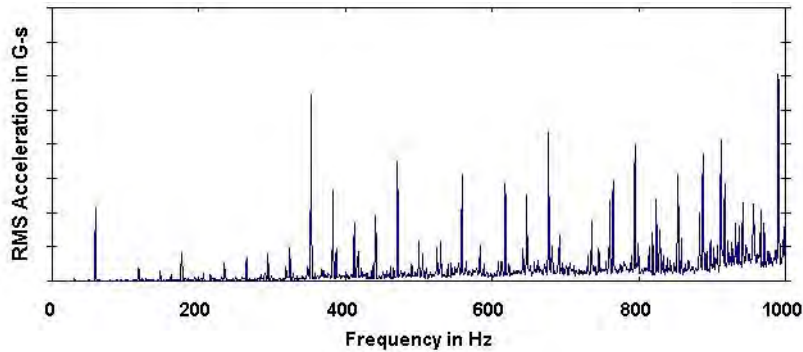
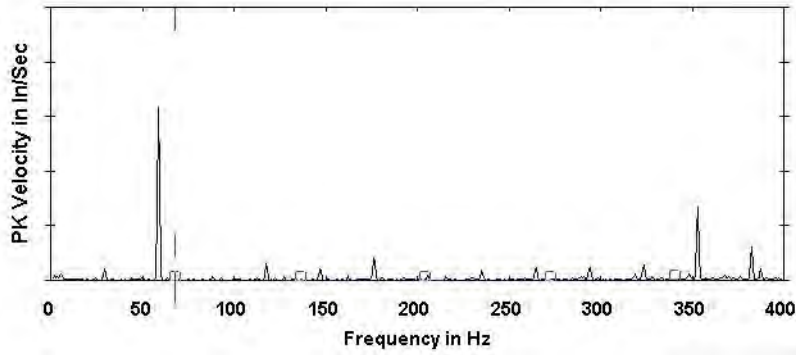
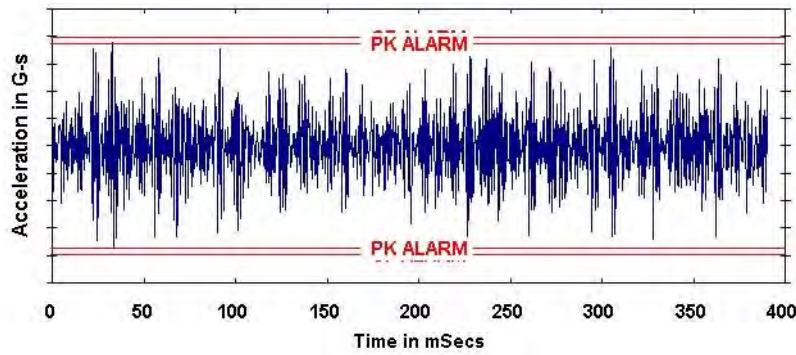
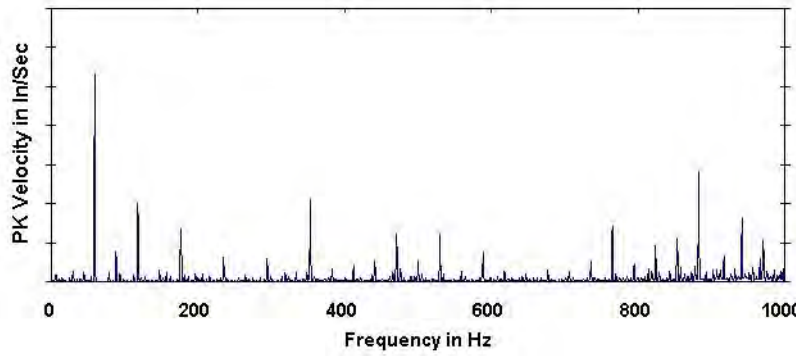
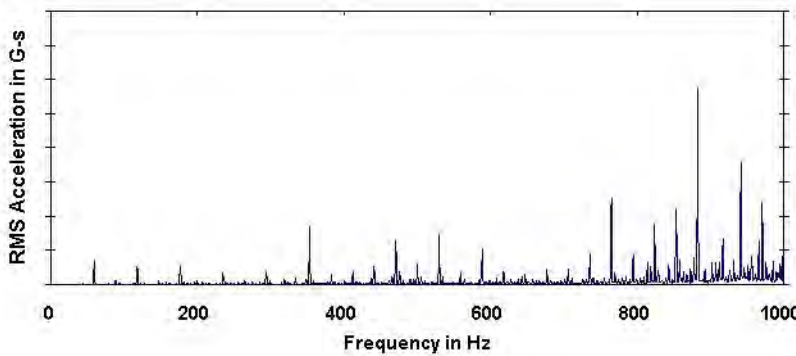
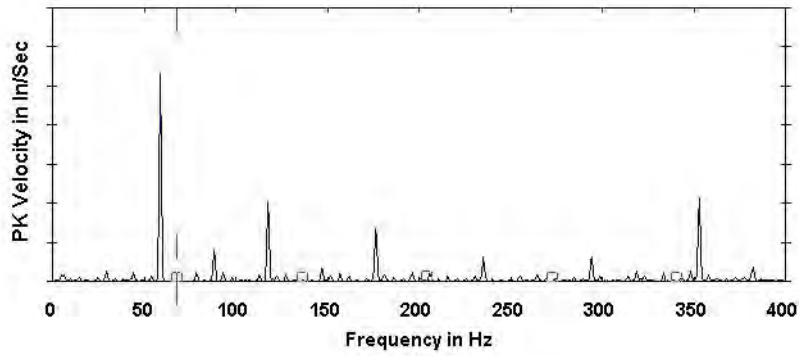
Comparisons of the waveform data shown in figures 53, 57, 61, 65, 69 and 73 and the velocity frequency graphs provided in figures 54, 58, 62, 66, 70, and 74 do not reveal anything is obviously amiss with the worn unit. The acceleration frequency graphs displayed in figures 55, 59, 63, 67, 71, and 75, however, highlight the effects of the wear. The wear has induced amplitude increases between 400 – 1000 Hz. Installation of the worn components in the good unit demonstrates that the worn ring gear components lead to the amplitude increases between 400 – 800 Hz, while the worn cycloidal discs and slow speed rollers affected the amplitudes between 800 – 1000 Hz. The red lines in figures 56, 60, 64, 68, 72, and 76 illustrate that the wear had no influence on the cycloidal disc mesh frequency amplitudes.

Figure 53. Waveform - test unit with bad cycloidal discs

Figure 54. Velocity frequency graph - test unit with bad cycloidal discs

Figure 55. Acceleration frequency graph - test unit with bad cycloidal discs

Figure 56. Cycloidal disc mesh frequency graph - test unit with bad cycloidal discs

Figure 57. Waveform - good unit

Figure 58. Velocity frequency graph - good unit

Figure 59. Acceleration frequency graph - good unit

Figure 60. Cycloidal disc mesh frequency graph - good unit

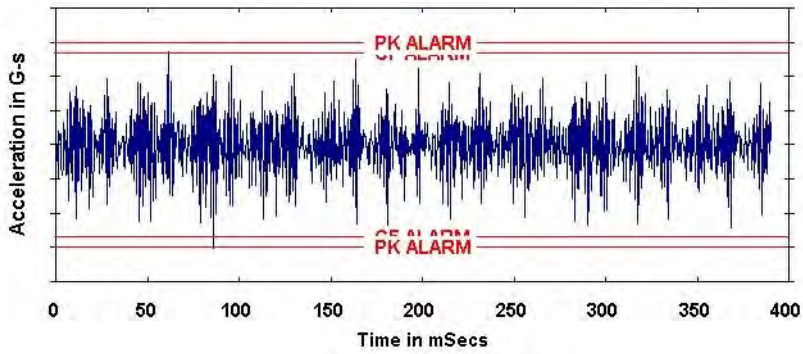
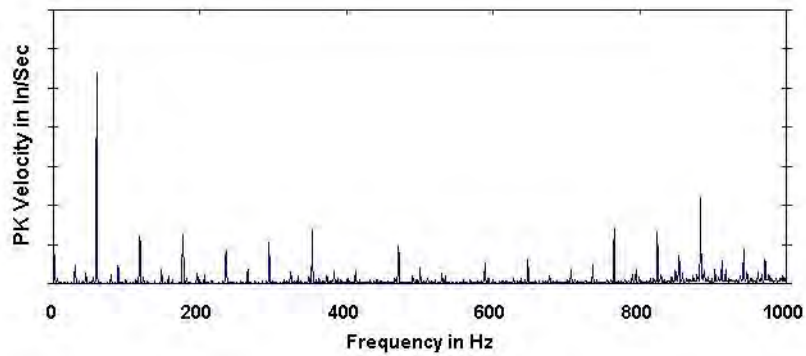
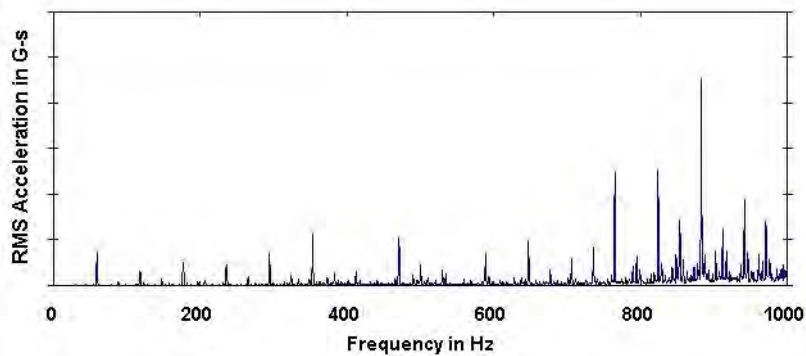
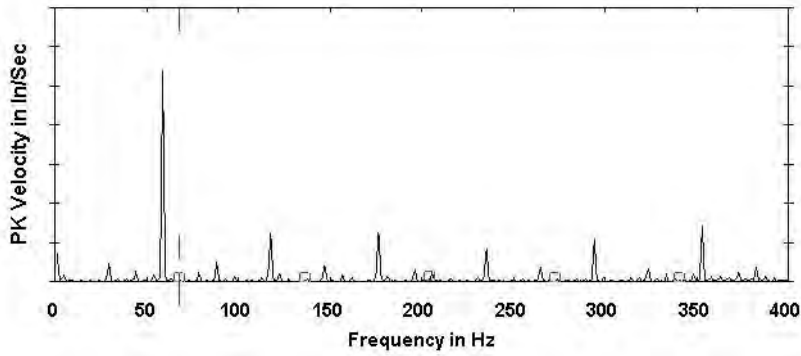
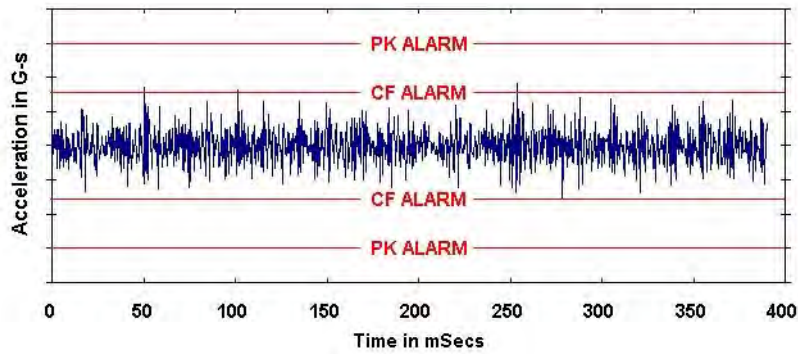
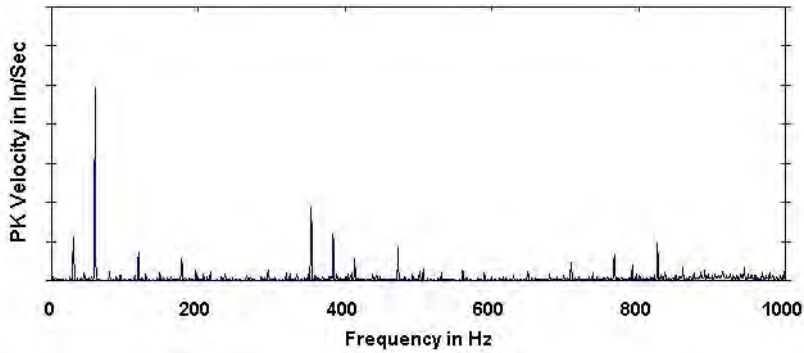
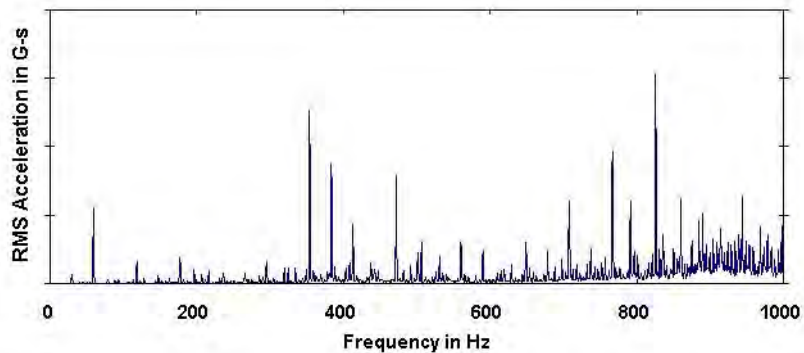
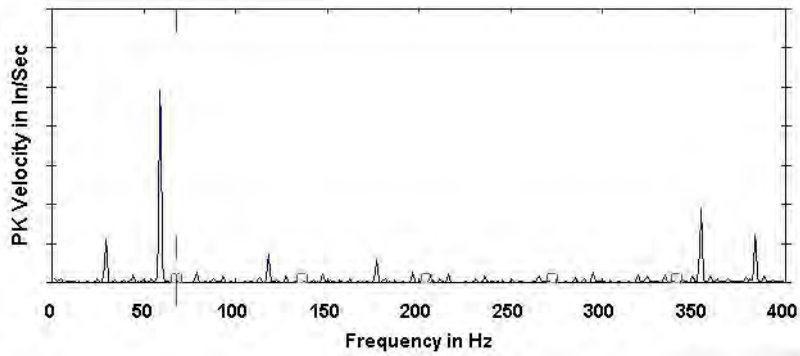
Figure 61. Waveform - good unit with bad cycloidal discs; see figures 53 and 57 for comparison

Figure 62. Velocity frequency graph - good unit with bad cycloidal discs; see figures 54 and 58 for comparison

Figure 63. Acceleration frequency graph - good unit with bad cycloidal discs; see figures 55 and 59 for comparison

Figure 64. Cycloidal disc mesh frequency graph - good unit with bad cycloidal discs; see figures 56 and 60 for comparison

Figure 65. Waveform - good unit with bad ring gear pins; see figure 57 for comparison

Figure 66. Velocity frequency graph - good unit with bad ring gear pins; see figure 58 for comparison

Figure 67. Acceleration frequency graph - good unit with bad ring gear pins; see figure 59 for comparison

Figure 68. Cycloidal disc mesh frequency graph - good unit with bad ring gear pins; see figure 60 for comparison
