08FTM02

A Methodology for Identifying Defective Cycloidal Reduction Components Using Vibration Analysis and Techniques

By V. Cochran and T. Bobak,
Sumitomo Drive Technologies

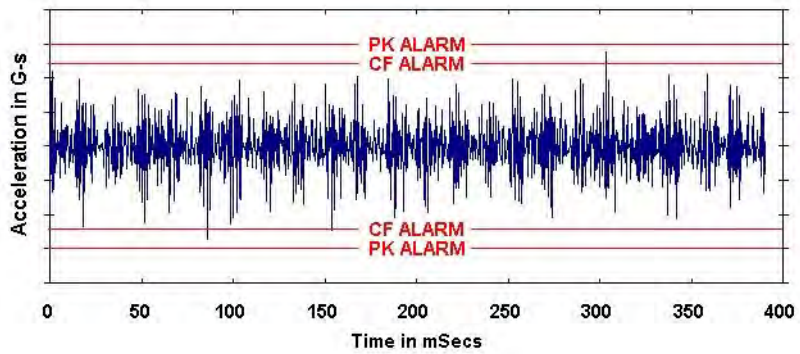
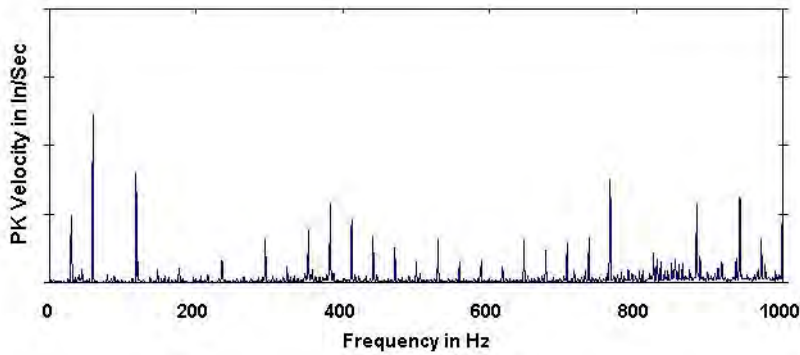
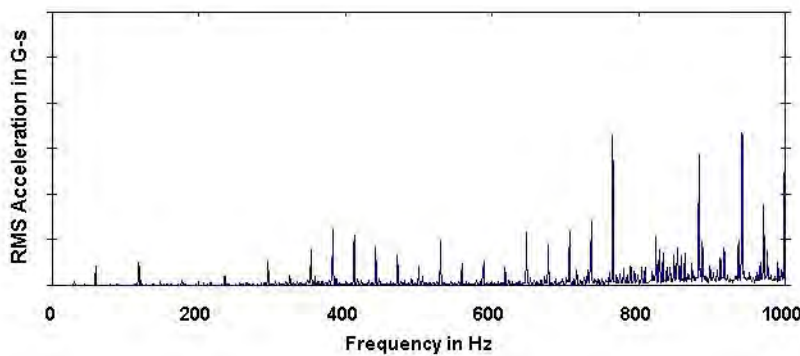
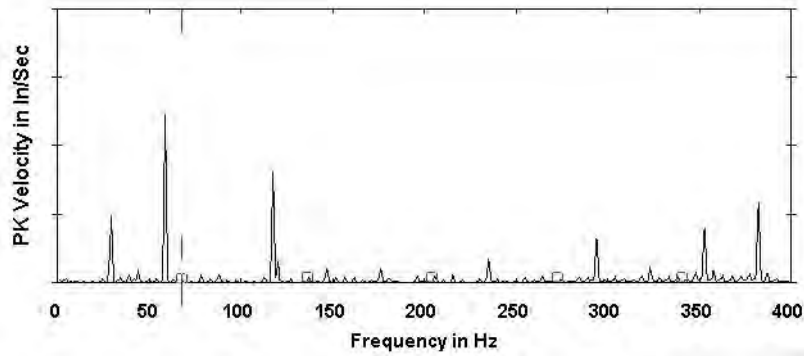
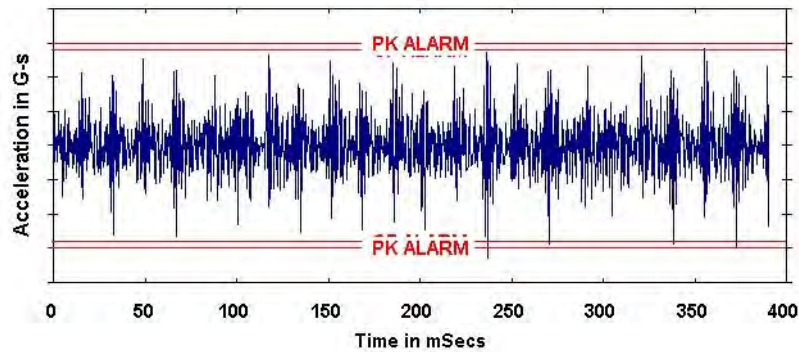
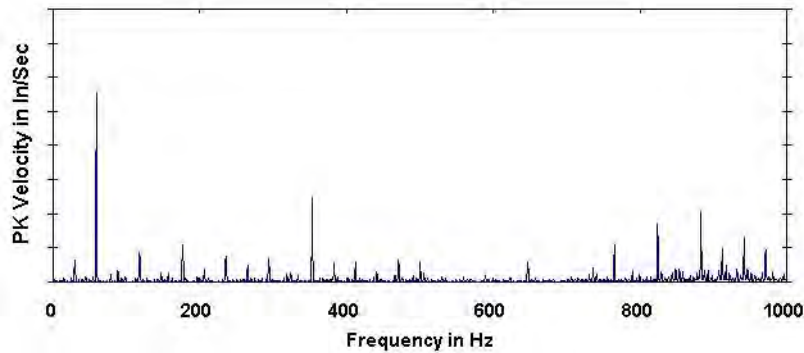
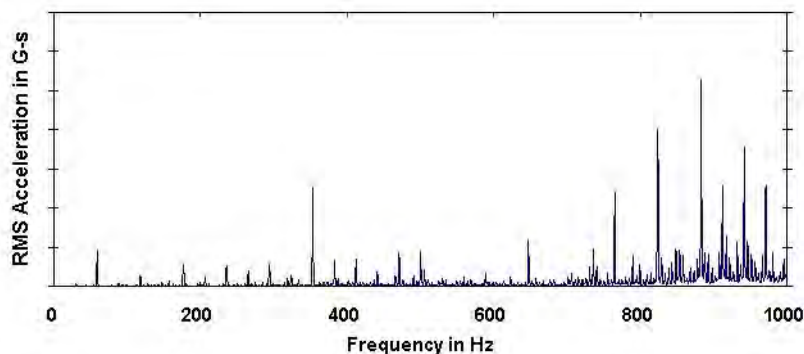
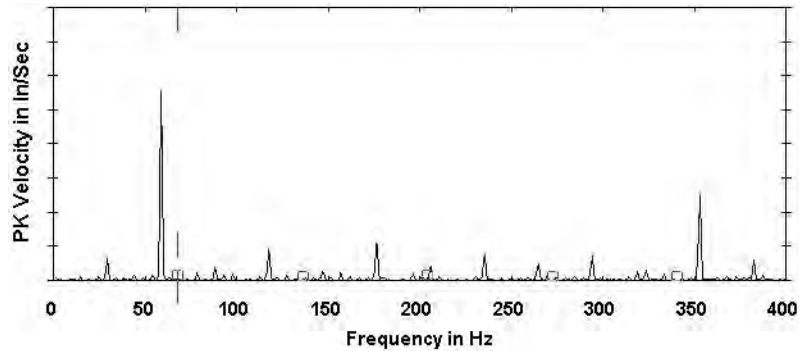
Comparisons of the waveform data shown in figures 53, 57, 61, 65, 69 and 73 and the velocity frequency graphs provided in figures 54, 58, 62, 66, 70, and 74 do not reveal anything is obviously amiss with the worn unit. The acceleration frequency graphs displayed in figures 55, 59, 63, 67, 71, and 75, however, highlight the effects of the wear. The wear has induced amplitude increases between 400 – 1000 Hz. Installation of the worn components in the good unit demonstrates that the worn ring gear components lead to the amplitude increases between 400 – 800 Hz, while the worn cycloidal discs and slow speed rollers affected the amplitudes between 800 – 1000 Hz. The red lines in figures 56, 60, 64, 68, 72, and 76 illustrate that the wear had no influence on the cycloidal disc mesh frequency amplitudes.

Figure 69. Waveform - good unit with bad ring gear housing; see figure 57 for comparison

Figure 70. Velocity frequency graph - good unit with bad ring gear housing; see figure 58 for comparison

Figure 71. Acceleration frequency graph - good unit with bad ring gear housing; see figure 59 for comparison

Figure 72. Cycloidal disc mesh frequency graph - good unit with bad ring gear housing; see figure 60 for comparison

Figure 73. Waveform - Good unit with bad slow speed shaft rollers; see figure 57 for comparison

Figure 74. Velocity frequency graph - good unit with bad slow speed shaft rollers; see figure 58 for comparison

Figure 75. Acceleration frequency graph - good unit with bad slow speed shaft rollers; see figure 59 for comparison

Figure 76. Cycloidal disc mesh frequency - good unit with bad slow speed shaft rollers; see figure 60 for comparison
