# WHAT ARE YOUR BEARINGS & GEARS TELLING YOU?

BY SCOTT FRANKS, PE

## A LOOK AT TYPICAL BEARING FAILURES, DAMAGE, AND CAUSES IN GEARBOXES

A LOOK AT TYPICAL GEARING FAILURES, DAMAGE, AND CAUSES IN GEARBOXES

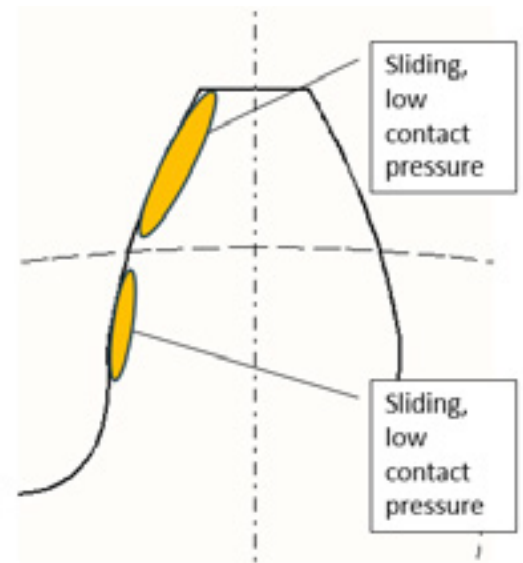
- Wear / Polishing: wear at tip / root
- Spalling: begins below the pitch diameter, looks like pitting but is caused by sliding + moderate contact pressure. crack initiates from the surface, sliding + contact pressure tends to "open" the crack until the particle is removed from teeth.
- Scoring (Scuffing): Tooth surface asperities instantaneously "weld" together then tear causing heavy wear marks on tooth tip

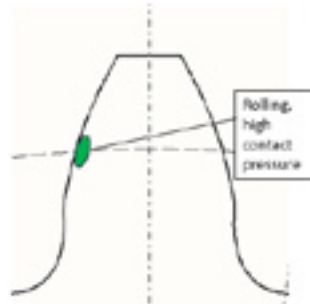
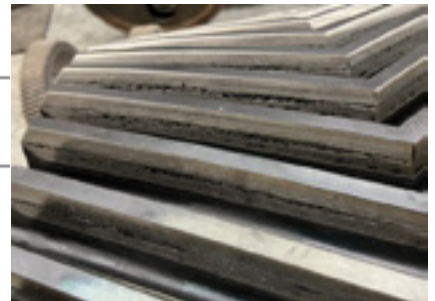
Looks like pitting but is a case-hardening failure phenomenon.

The two most common damage due to rolling contact pressure are pitting for through hardened gear and case crushing for carburized gears.

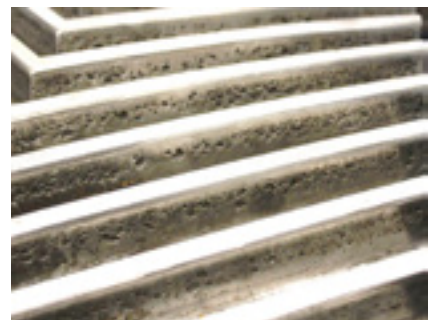
When the cracks have grown long enough to separate a piece of the surface material, a pit is formed.

- Fatigue cracks initiate at a shallow depth below the tooth flank surface where localized points of subsurface compressive stress exceed the material strength.
- The crack propagates for a short distance in a direction roughly parallel to the tooth surface before turning or branching to the surface.

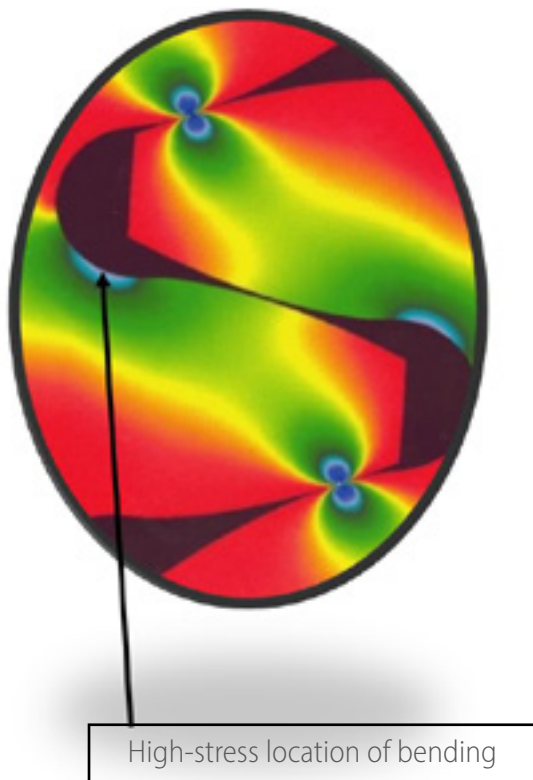
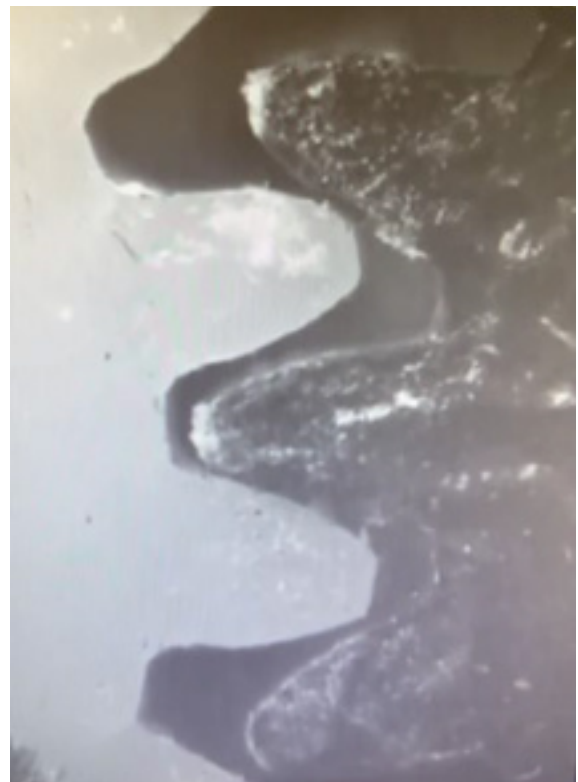
## BENDING FATIGUE

Destructive pitting initiating a fracture is the most common cause we see

- The bending stress of the tooth exceeds the ultimate strength of the tooth.
- Tooth wear that causes stress riser in root of tooth
- Destructive pitting and wear can initiate cracks due to bending cycles of a tooth and eventually the cross section of the tooth can no longer carry the load
- A step in the root of the tooth created during the manufacture of the tooth
- Excessive load is more than the tooth section can carry
- Misalignment that overloads the area of a tooth
- Bad installation
- Failed bearing

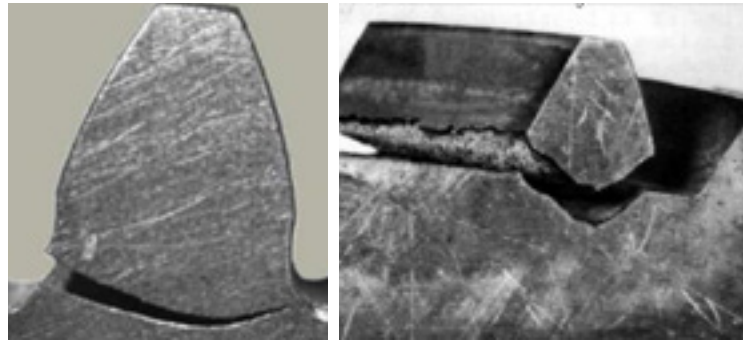
## TOOTH FRACTURE SURFACE CAN TELL A STORY

The fracture surface lets you identify an instantaneous failure or one that was created by cyclic loading. Beach marks of a bending fatigue fracture will lead back to the initiation point.
