PROBLEM & SOLUTION

Industry: Food & Beverage
Application: Animal Rendering (Non-Meat)
Result: Doubled Gearbox Life and Eliminated Belts
Products Used: Bevel BuddyBox® 4 Screw Conveyor

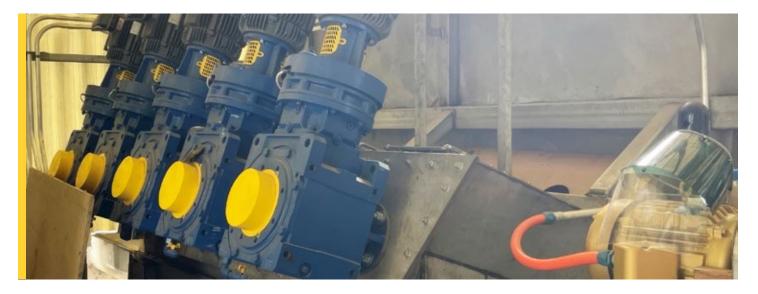
Our Bevel BuddyBox[®] 4 units have a **NEMA frame input** for **versatile motor attachment**. With the NEMA adapter design, the **belts are eliminated** and the motors have **no external loading** due to the coupling connection of the adapter. Our technical engineers added external piping and an oil expansion chamber to ensure the input bearing would be **well-lubricated** without an extensive pressure build. This addition will extend the life of the **oil seals**.

We also added a **screw conveyor adapter** to make it **easy to mount** the unit to the conveyor.
